BEST PRACTICES OF GROUND WATER / WATER SOURCES

2. Rainfall measurement (Village Titvi , Taluka Parola , District : Jalgaon)

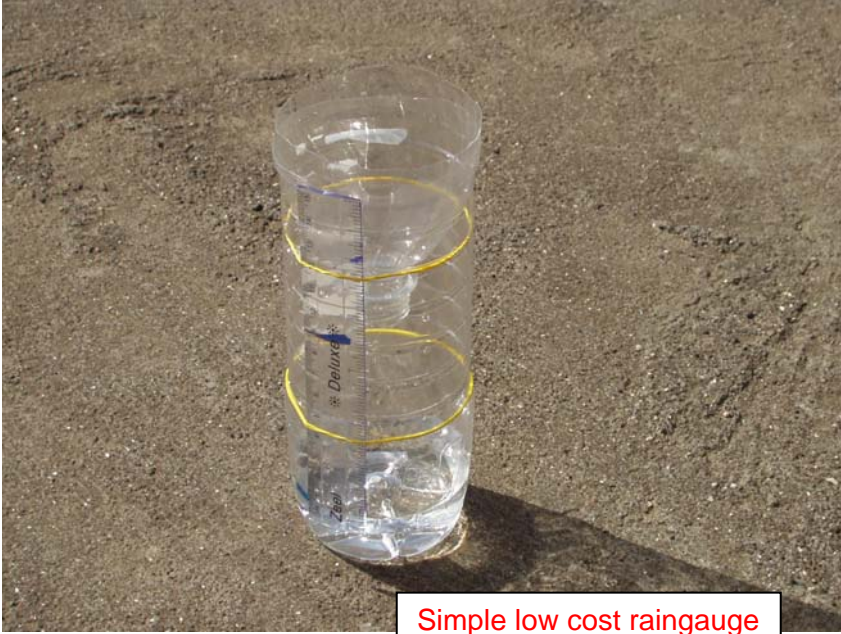
In Adgaon (Yaval Taluka), Titvi (Parola Taluka) and Malshevga (Chalisingaon Taluka) raingauges have been made and rainfall recording has started. Daily rainfall can be monitored using a rain gauge made from a mineral water bottle with top removed and inverted (as photo above). This has to be placed in a location where trees or buildings do not interfere with rainfall, preferably on a roof and with a scale in mm.

Simple low cost raingauge
