## Restoration of the Traditional Small Water Bodies in Braj

### ABSTRACT

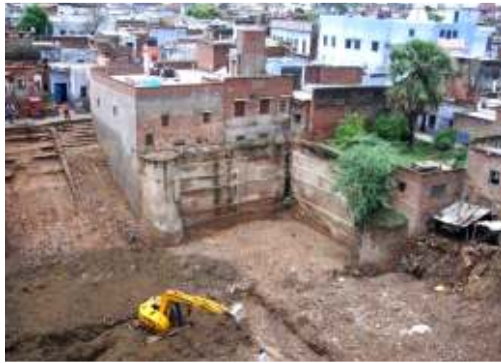
Plate 1 Brahma Kund, Vrindavan  
(Courtesy: The Braj Foundation, U.P., India)

1. **Rapid urbanization:** Due to rapid urbanization, the areas surrounding many of the kunds have been encroached upon and habitations have been built up. As a result, the catchment area contributing to the kunds are existing no more. Sewage systems or domestic wastes in some places find their opening into some of the kunds, for which some of the kunds have turned into garbage tanks. Plate 1 shows Brahma Kund in Vrindavan engulfed by the habitations.

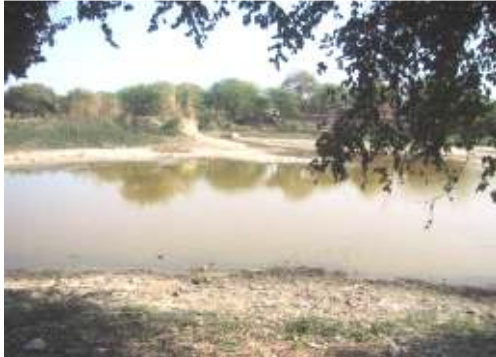
Plate 3 Dharam Kund, Jao  
(Courtesy: The Braj Foundation, U.P., India)

may be rich in organic matter and nutrients which become available to algae or macrophytes immediately or some later stage. This fosters further spread of macrophytes or algae, which ultimately promote further loss of DO and release of organic molecules and nutrients as they decay (Carpenter et al., 1998). Plate 3 and 4 shows silt-laden water and macrophytes infestation in the kunds, respectively.

4. Sediment removal: This technique can be multipurpose, resulting in control of both algae and macrophytes. It is an effective procedure and is frequently used for deepening shallow water bodies for curtailing internal nutrient loading by eliminating the enriched sediment layer and macrophytes control. It has a significant long-term advantage over nutrient inactivation due to the fact that the source is removed rather than bound in place as in case of P inactivation. The limitations of this technique are the relatively high cost of dredging and the requirement of adequate dredged material disposal sites.
