Kerala State Council for Science, Technology & Environment

ENVIRONMENTAL MONITORING PROGRAMME ON WATER QUALITY

Centre for Water Resources Development & Management

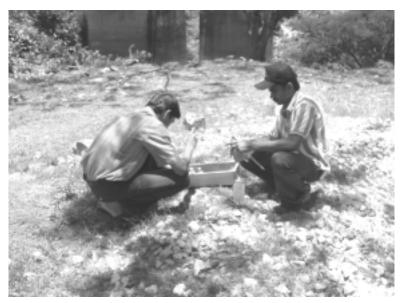
Plate 1.2: Fixing Dissolved Oxygen at Sampling site

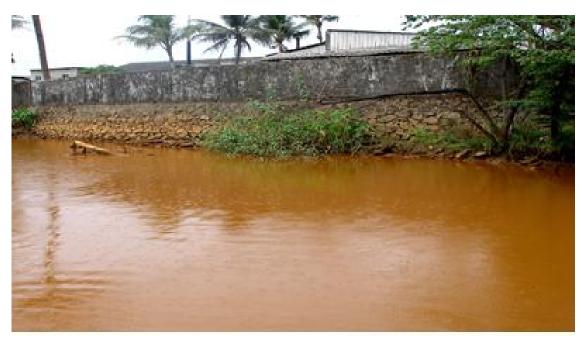
Plate 2.6: Periyar river with reddish water

On 18 Dec 2007, the water of Periyar again showed discoloration. The colour suddenly changed to red. The discoloration occurred at Pathalam Bund near Eloor which houses the Udyogamandal Industrial Estate. The details of sampling sites are given in Table 2.12 and Fig 2.20.

Cochin Minerals and Rutile Ltd (CMRL): It manufactures 70 tons per day of synthetic rutile (an intermediate in the manufacture of Titanium dioxide) through chloride route and roughly 90 tons of other by-products per day. Ferrous chloride is produced as a byproduct which is a toxic waste. These iron particles can be oxidized and may lead to the formation of red brown ferric hydroxide.

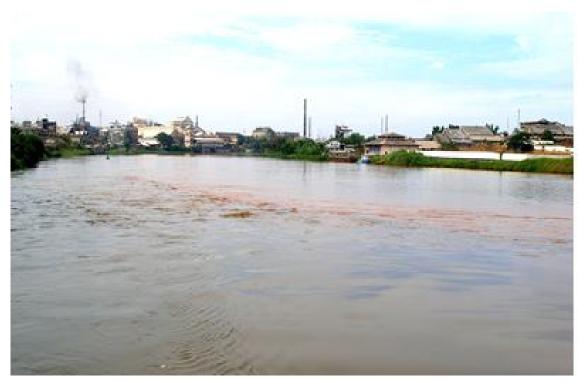
Plate 2.7: Discoloured Periyar river

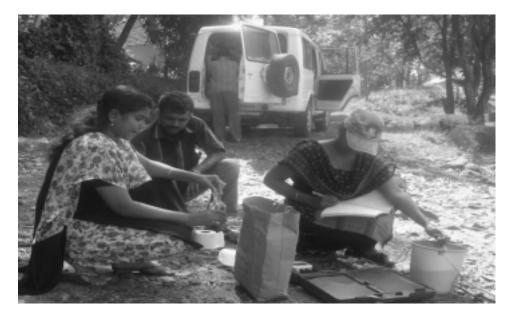
Plate 3.3: In-situ analysis of water samples

The containers used for sampling were pre-cleaned, non reactive plastic bottles of 1 litre capacity and sterilized bottles of 100ml capacity for physico chemical and microbiological analysis respectively. Specially designed glass bottles were used for DO & BOD sampling. Parameters like pH, temperature and electrical conductivity were measured in-situ. Also, the samples for the analysis of dissolved oxygen were fixed at the spot (plate 3.1 to 3.3).

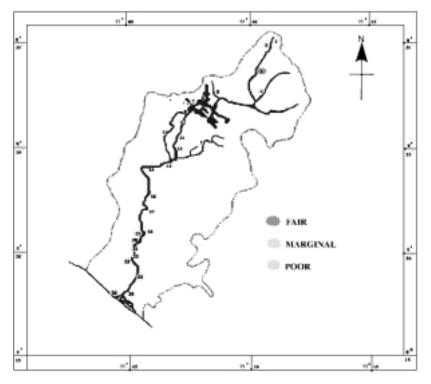
Fig. 3.10: CCME, Water Quality Index of Neyyar river.

Canadian Council of Ministers of Environment (CCME) water quality index has been worked out for the Neyyar river using the seasonal analytical data. The results are presented in Fig 3.10 and Table 3.5
