REPORT ON
THE NH-57 AND RAILWAY BRIDGE OVER
THE KOSI RIVER AT NIRMALI

THE NH-57 AND RAILWAY BRIDGE OVER THE RIVER KOSI AT NIRMALI

SYNOPSIS

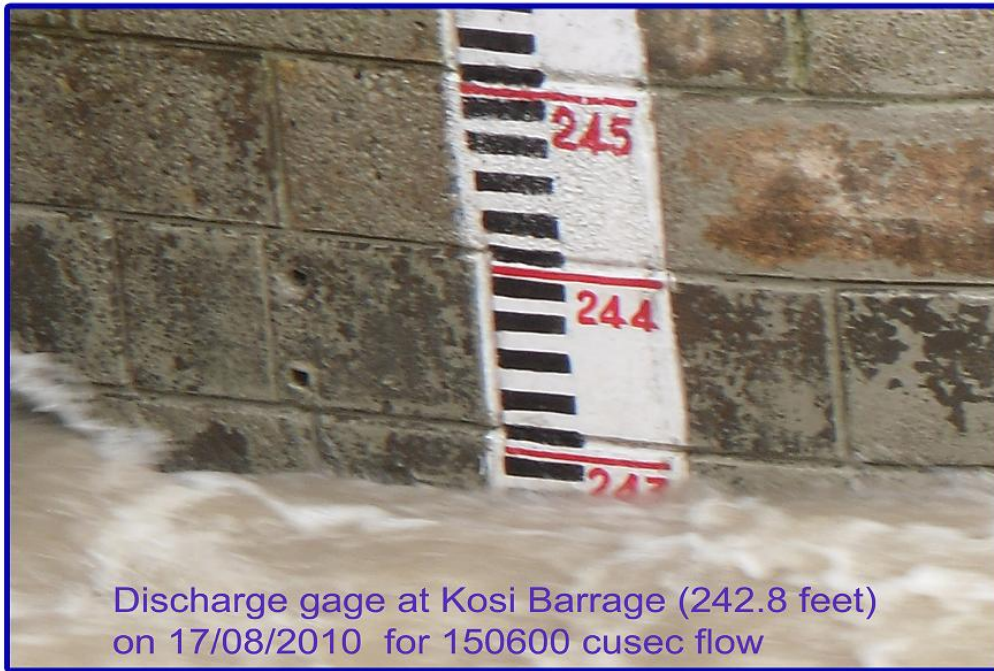
Photo 1. The River Kosi Discharge Gage Reading at Bhimnagar Barrage on 17.08 2010 at 1200 Hrs.

prediction. At the river discharge of 1 50 600 Cusec (4265 cumecs), recorded on the 17th August 2010 at 12:00 Hrs at the Kosi Barrage at Bhimnagar (photo 1&2), the afflux was over 3m and back water spread far upstream (photos 3&4). This caused heavy flooding of human habitations, deposition of sand in arable lands, and destruction of private and public properties (Photo 5, 6). Over thirty school buildings were rendered dysfunctional. The afflux bund cum protection embankment of the NH-57 on the left, which had blocked the flow of two secondary channels, breached downstream of Bhaptiyahi and was washed away in to the swirling current (Photo 7). This breach was enlarged to a length of nearly three kilometers. All attempts to plug this breach and stop the erosion were in vain till the end of monsoon. As a consequence of the breach of the afflux cum protection embankment, nearly four Km long eastern segment of the approach road of the NH 57 Bridge also got washed off into the River Kosi. This segment of the NH-57, constructed in the flood plains of the Kosi, had been washed away in the last monsoon too. Even after drainage of flood water downstream through this breach, the water level rose more than three meters high in the villages, which were located 15Km upstream of the bridge. One such example is the village Siani, 15 km away from the Bridge (Fig1). Here the rising backwater compelled inhabitants to leave their houses, carrying their thatched roofs on boats. The afflux level of upstream water, caused after construction of the afflux cum protection bunds on either side of the main channel was four to five times higher than the estimates made by the experts. As a result of this, water had entered the dwellings of the people, forcing their mass migration to higher places.

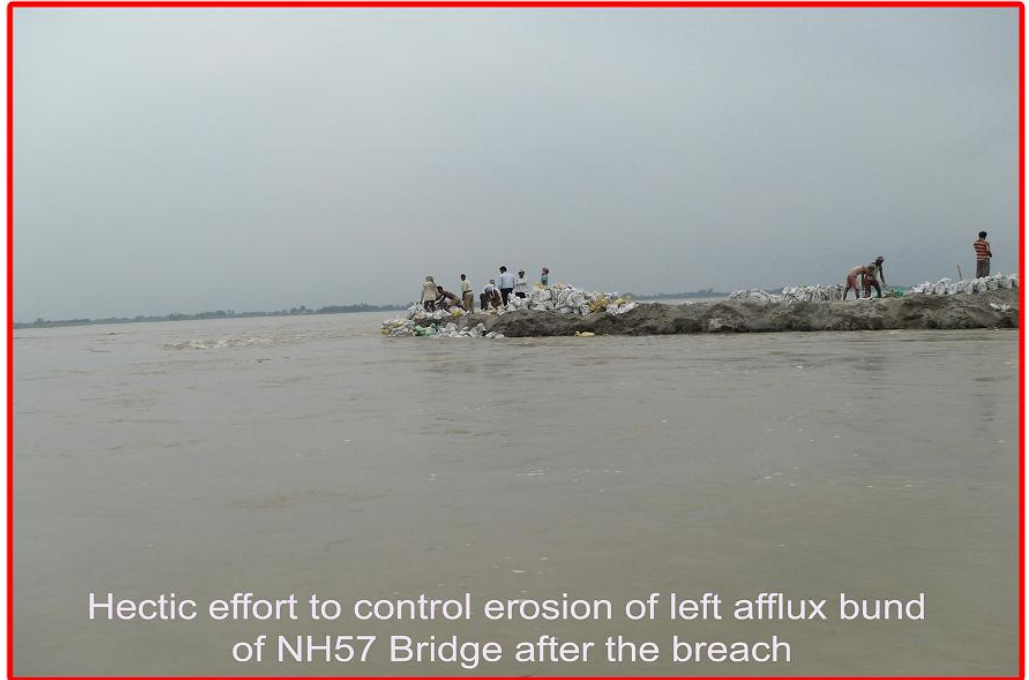
Photo 7. Breach in the Left Afflux cum Protection Embankment of the NH 57..

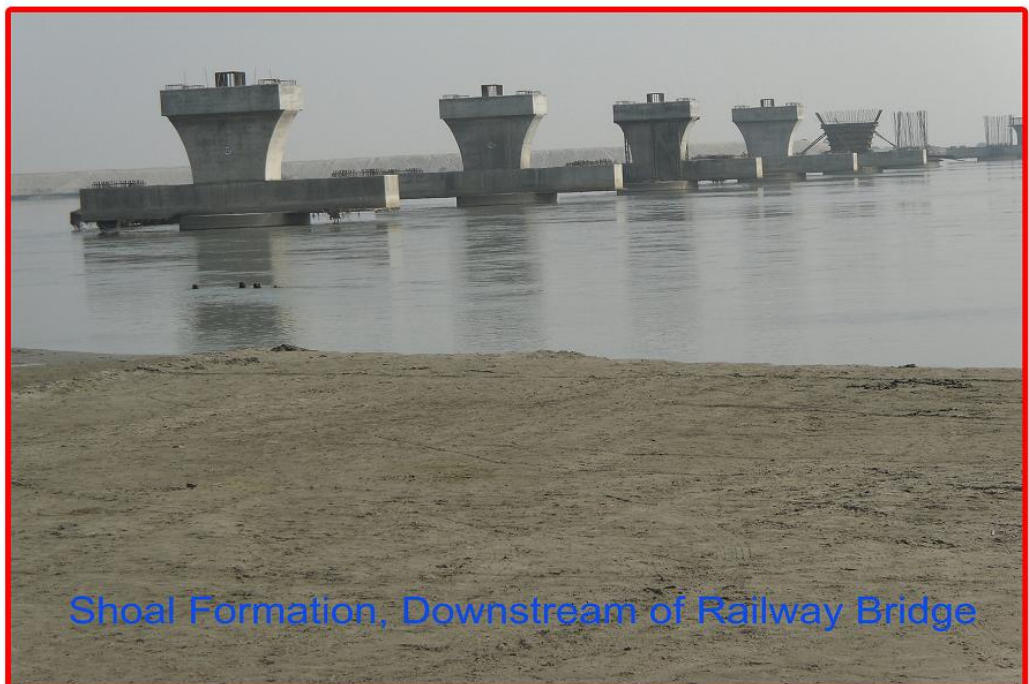
Photo 8. Shoal Formation Downstream of Railway Bridge Piers

8.3 After the end of the first monsoon floods it was evident from the site visit that shoal formation had started within 20 m downstream of the Railway Bridge towards right bank, between two guide bunds.(Ref. Photo 8). The channel flow had skewed towards the left bank, down stream of the Railway Bridge, washing away parts of the eastern guide bunds (Ref Photo 9) and village Naua Bakhar further approximately 2 Km downstream. There was evidence of scouring of the NH-57 Bridge piers, upstream of the Railway Bridge, after the first monsoon floods (Ref. Photo 10).

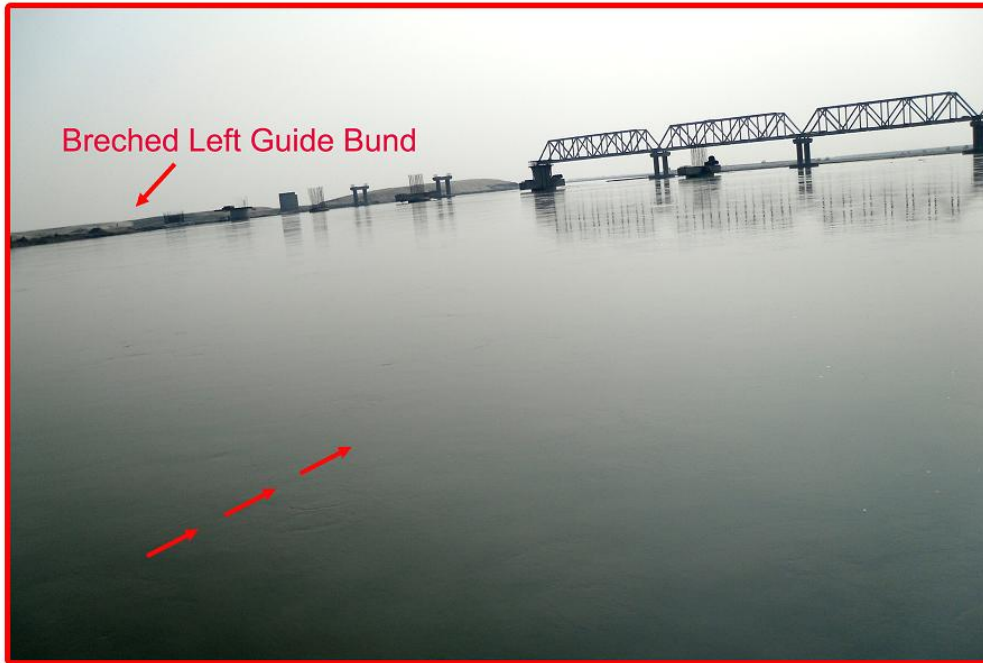
Photo 9. Breach in the Left Guide Bund

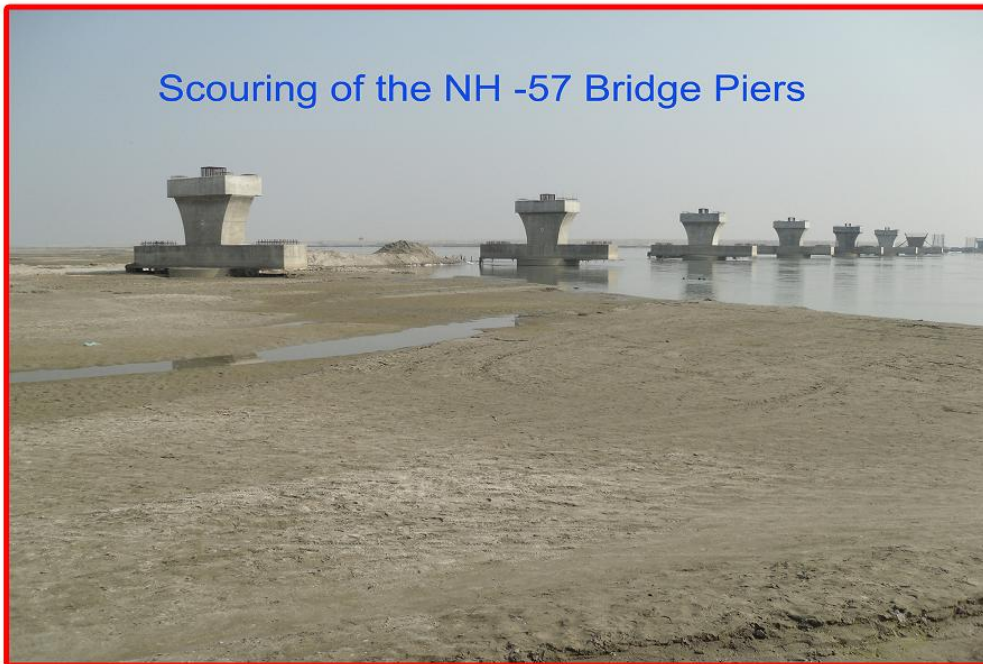
Photo 10. Scouring of the NH-57 Piers after the first Monsoon Floods in the River Kosi
