HYDROPOWER PROJECTS OF HIMACHAL PRADESH VIOLATING ENVIRONMENTAL NORMS WITH IMPUNITY WILL THE MEF ACT WITH REQUIRED URGENCY?

Karcham Wangtoo HEP This 1000 MW installed capacity hydropower project is under implementation on Sutlej River in Kinnaur district in Himachal Pradesh. The environment clearance to the project was given by MEF on Nov 9, 2005. Below we are giving photos from this project site showing the violations that this project is indulging in muck disposal into the river.

Himanshu Thakkar (ht.sandrp@gmail.com)
South Asia Network on Dams, Rivers & People (www.sandrp.in)

January 31 2011

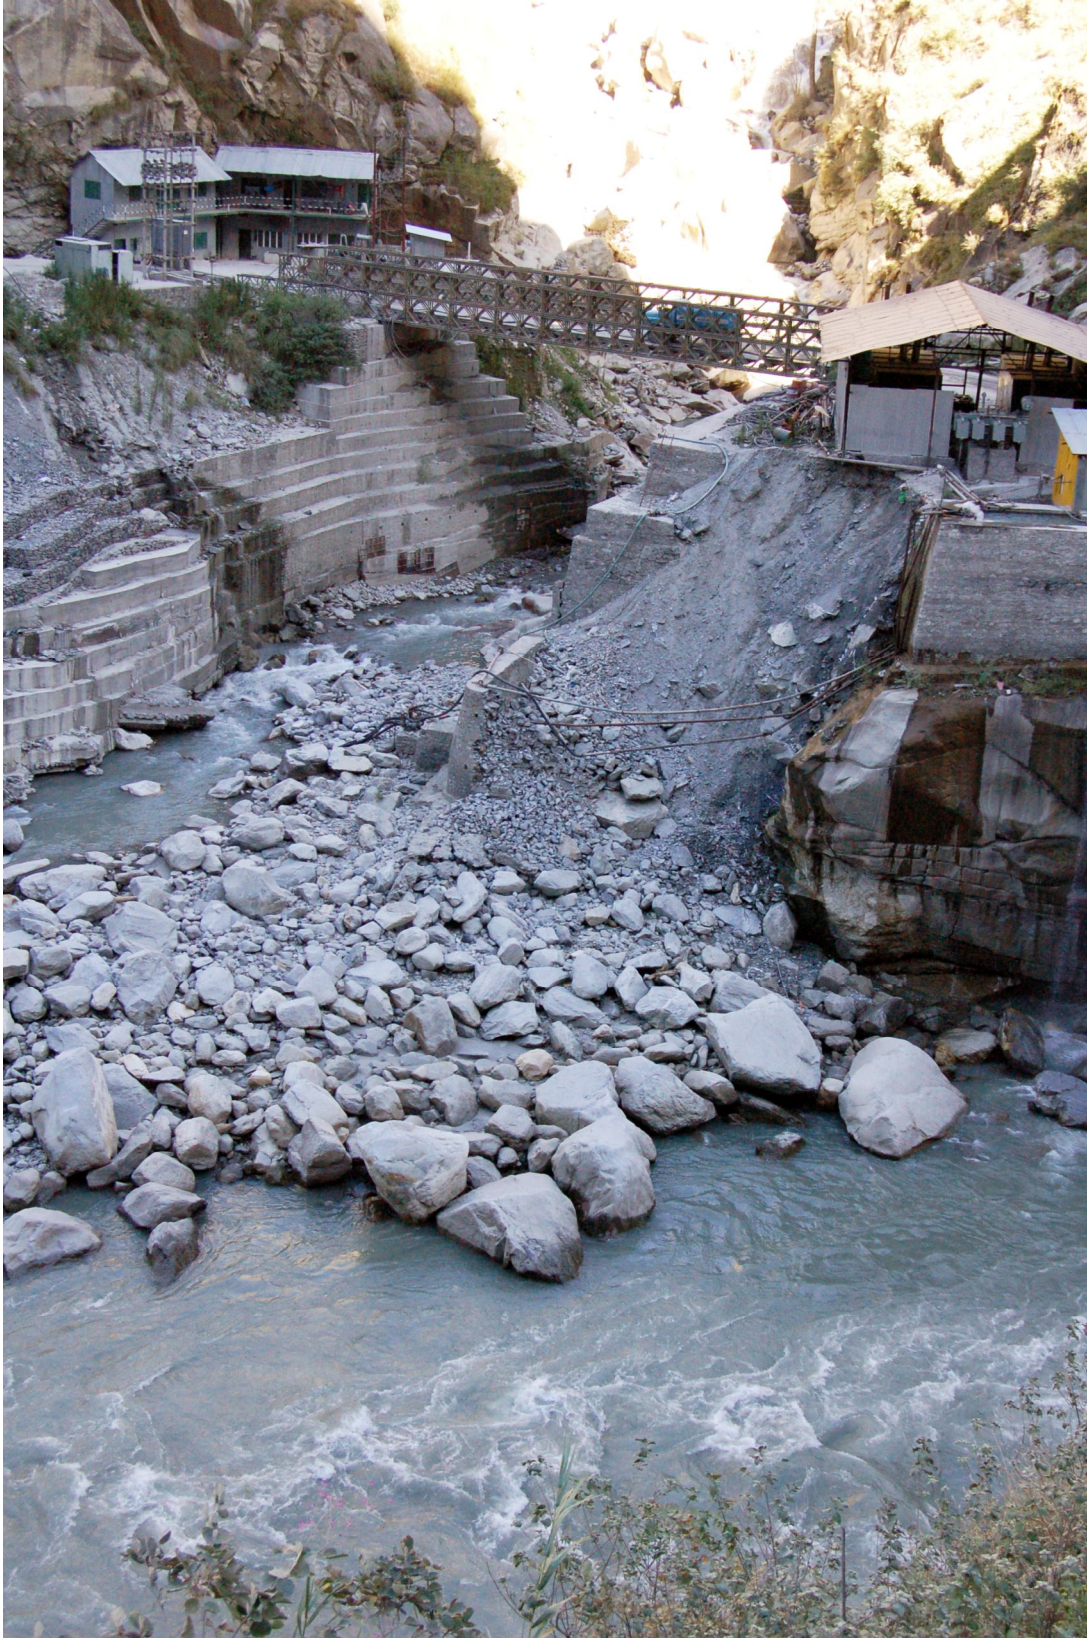
1. Photo showing how the muck is flowing into the Sutlej river. Photo taken a few km downstream from the dam site on Nov 10 2010

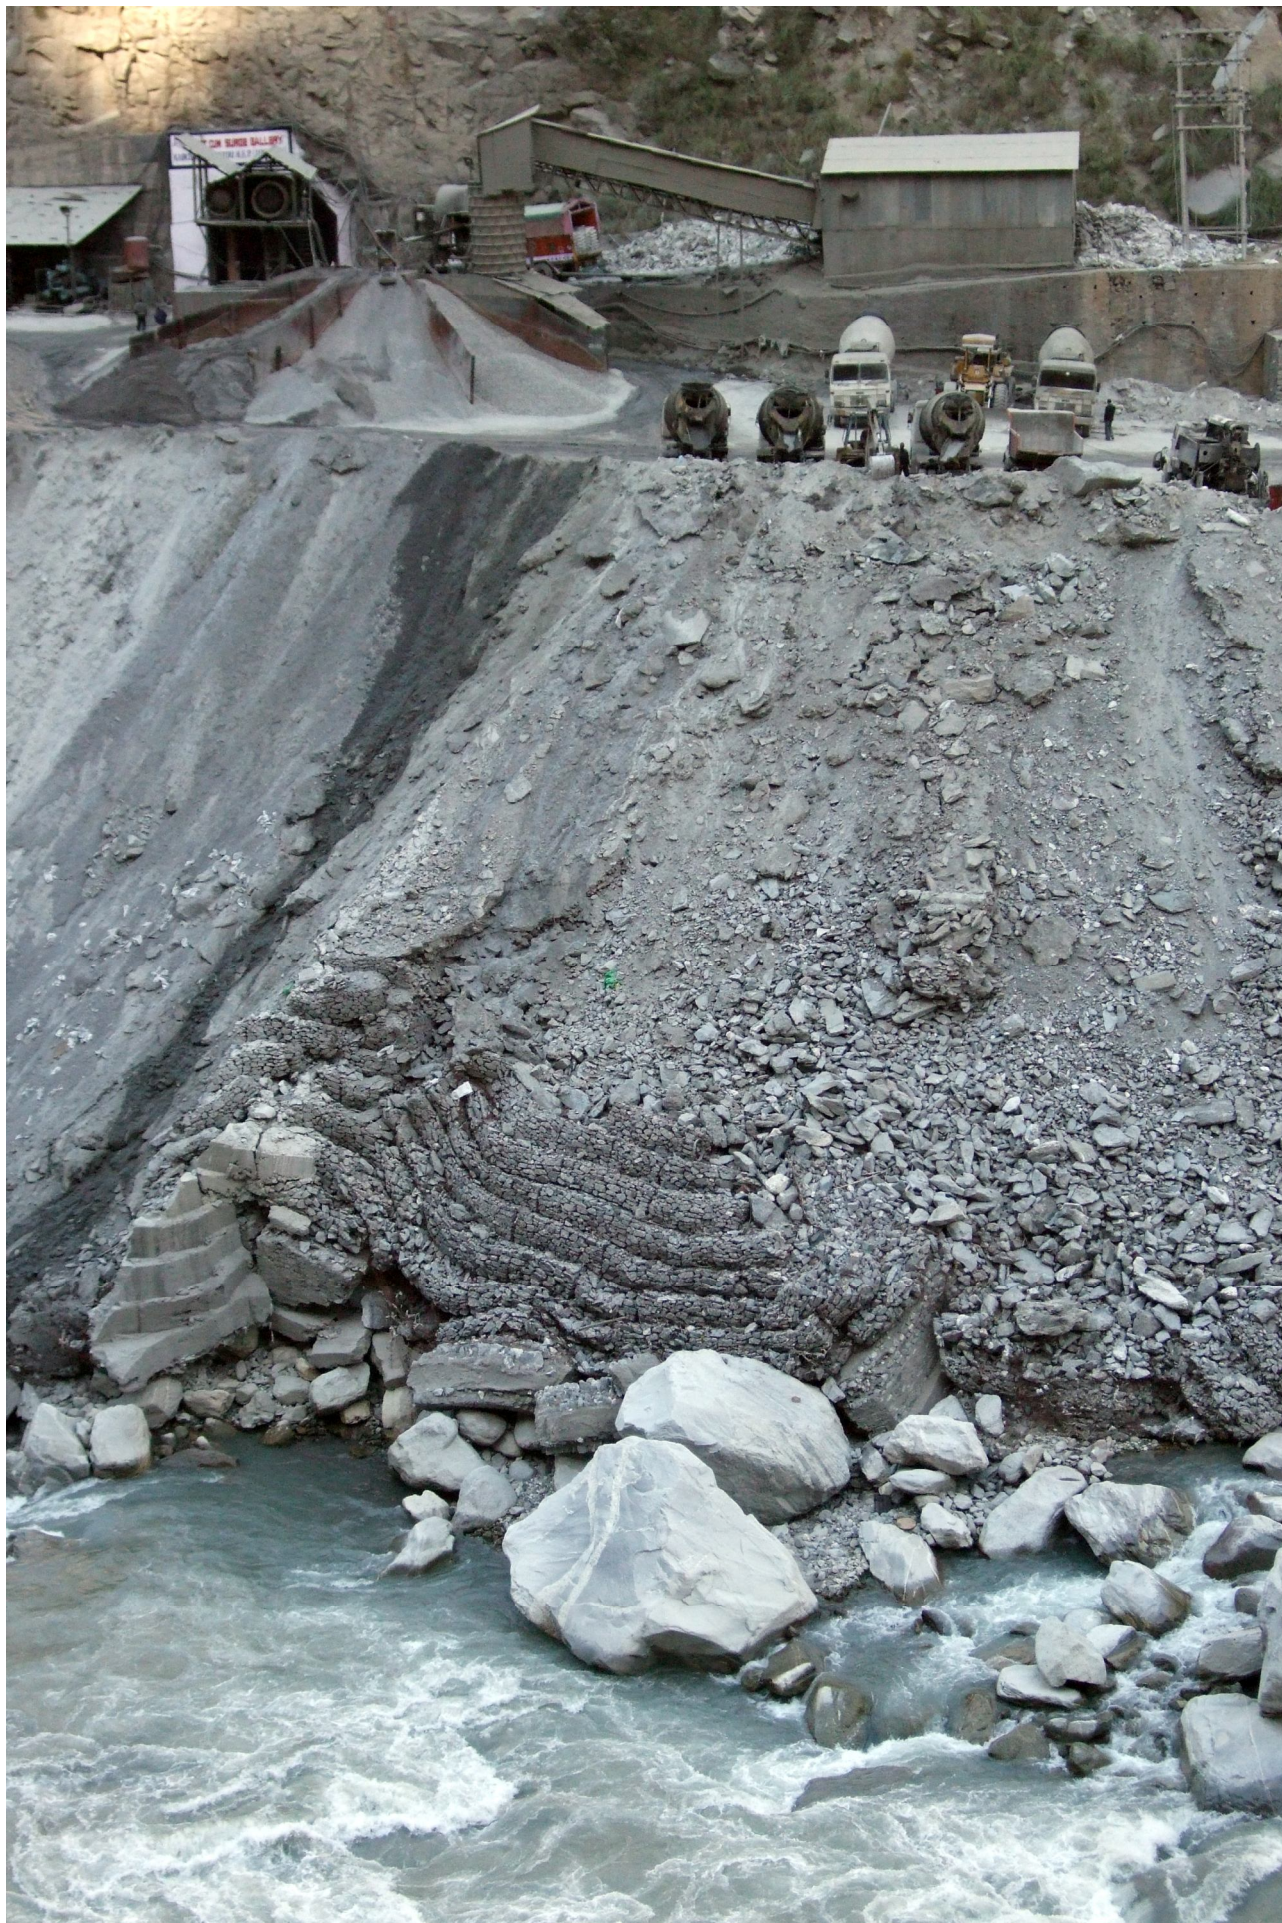
2. Photo 2 showing how the muck is flowing into the Sutlej river. Photo taken a few km downstream from the dam site on Nov 10 2010

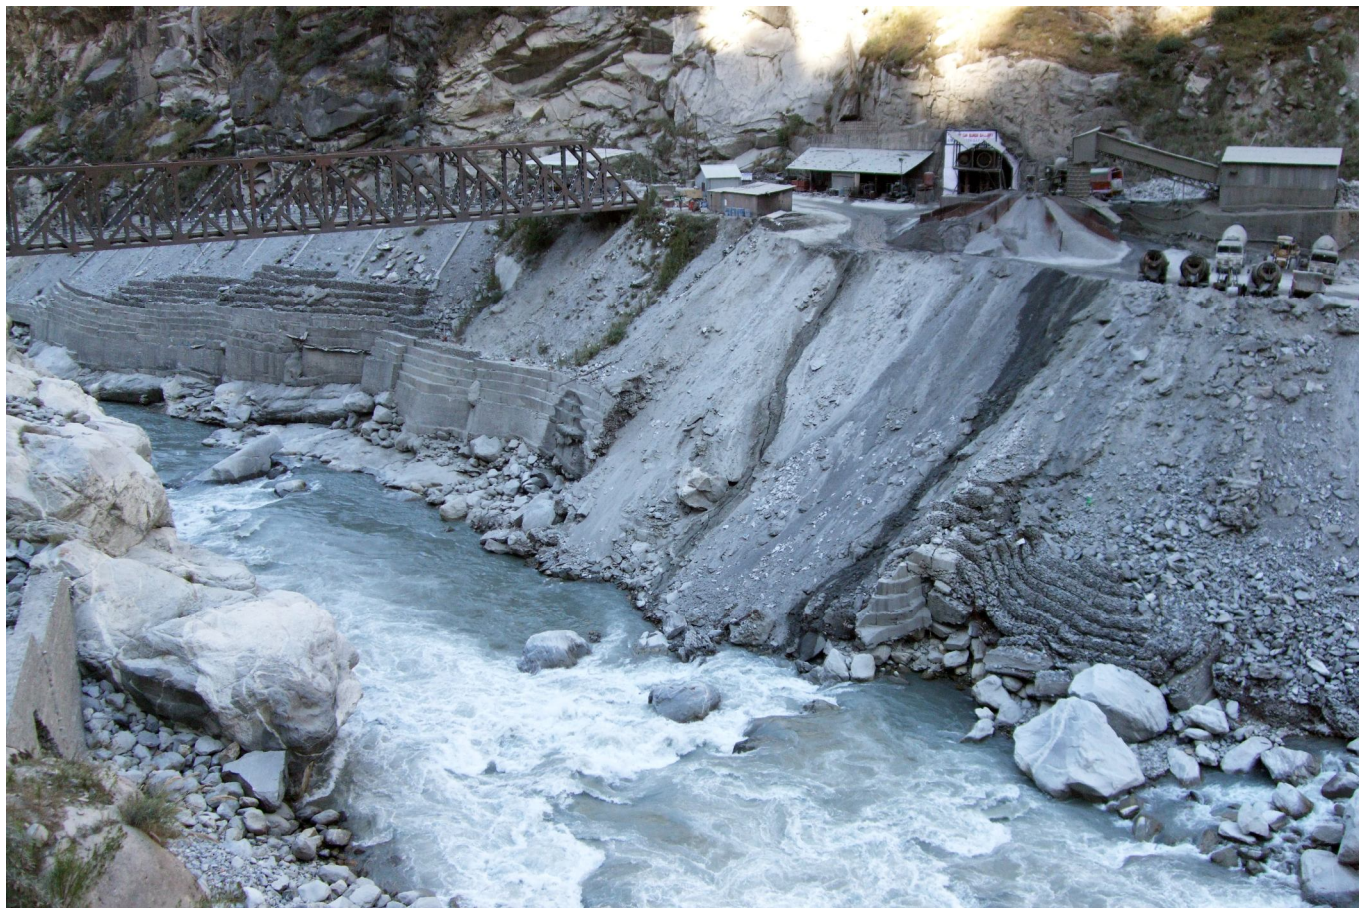
3. Photo 3 showing how the muck is flowing into the Sutlej river. Photo taken a few km downstream from the dam site on Nov 10 2010

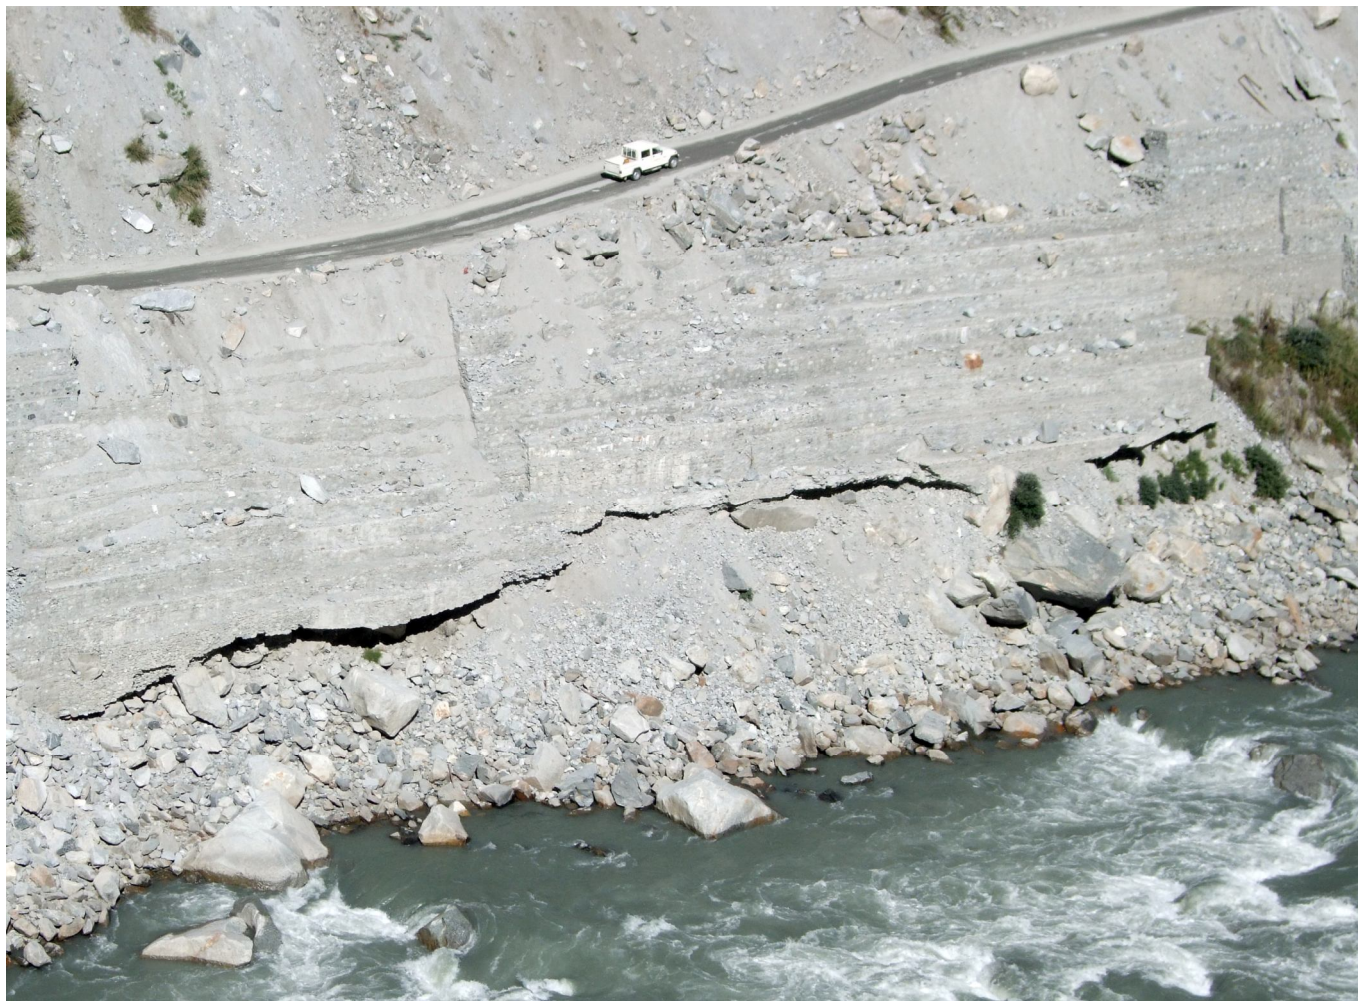
4. Photo 4 showing how the muck is flowing into the Sutlej river. Photo taken a few km downstream from the dam site on Nov 10 2010

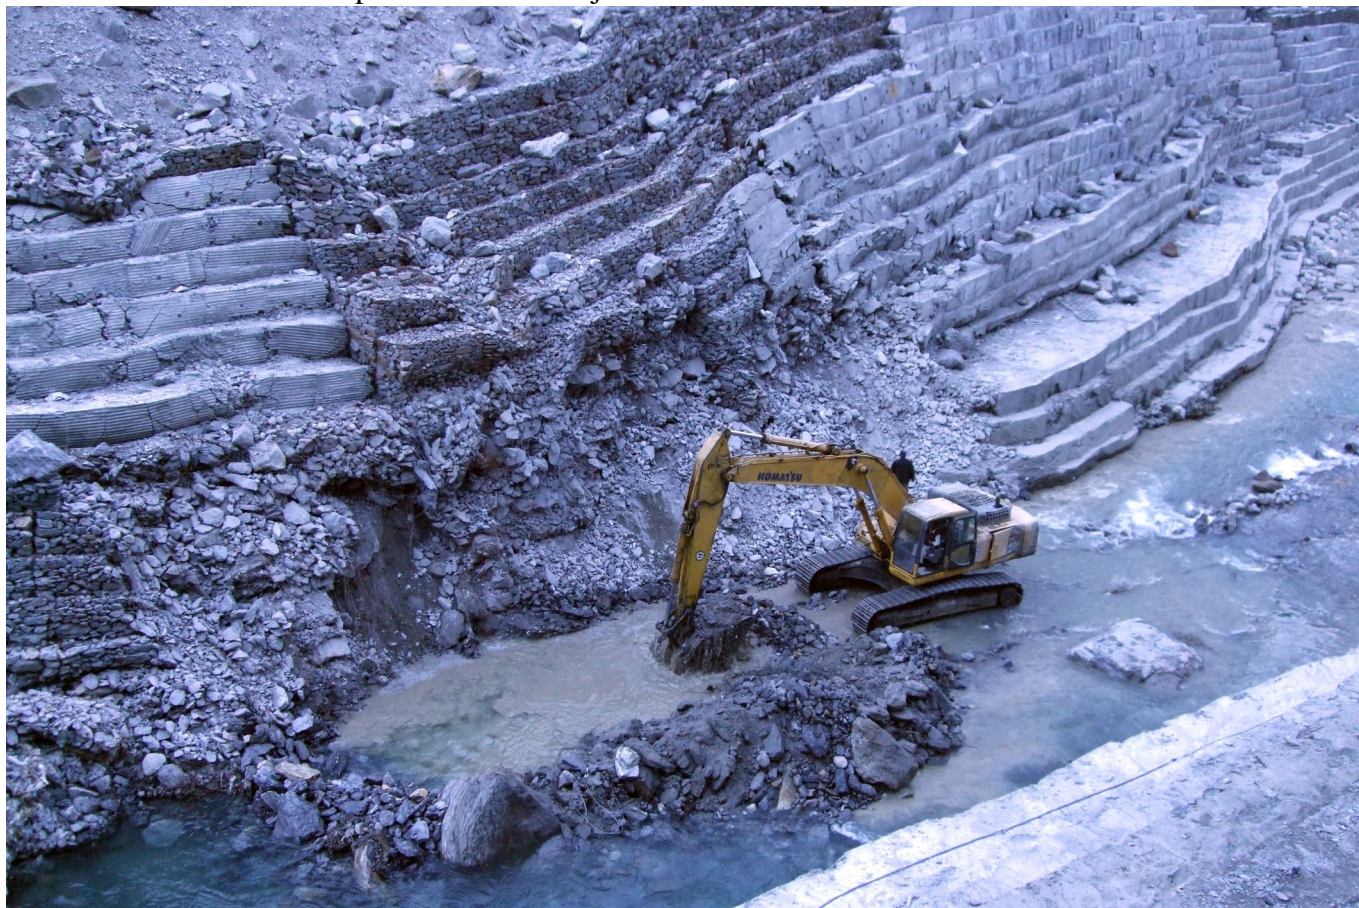
5. Photo 5 showing how the muck is flowing into the Baspa river. Photo taken a about 1 km upstream from the confluence of Baspa river with Sutlej river on Nov 20 2010

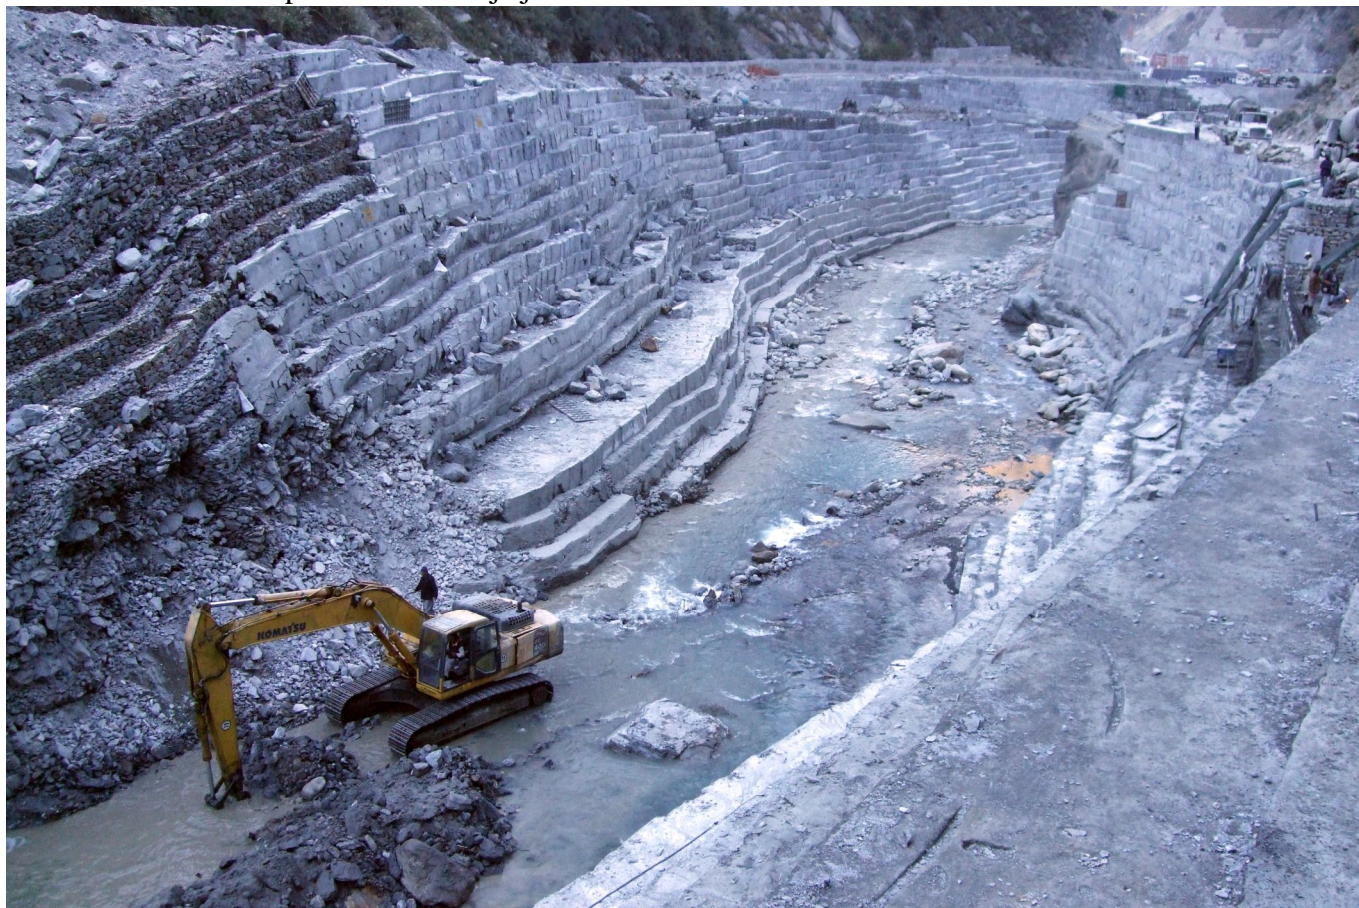
6. Photo 6 showing how the muck is flowing into the Baspa river. Photo taken about 1 km upstream from the confluence of Baspa river with Sujlej on Nov 20 2010

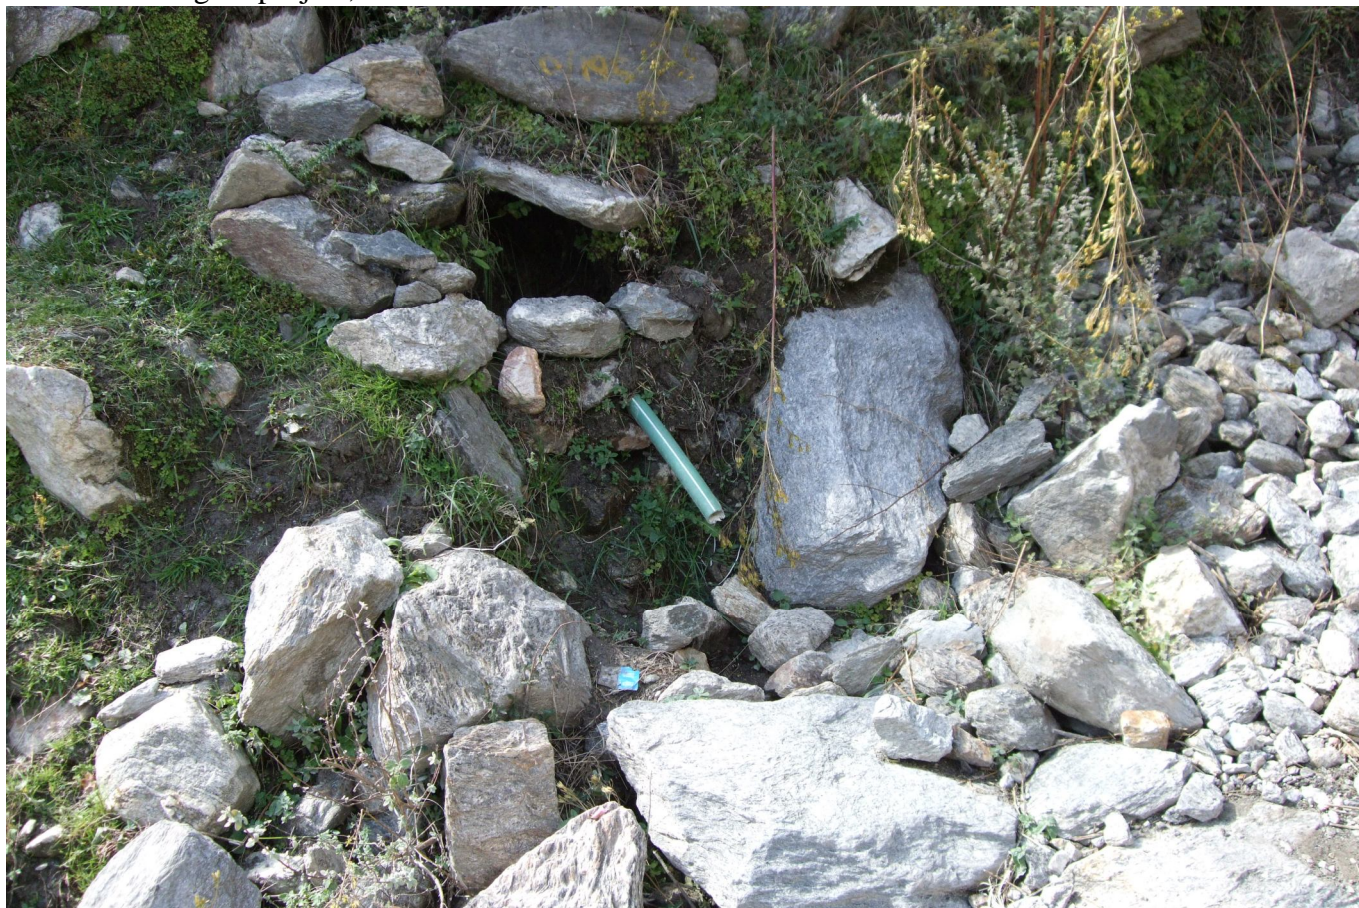
7. Photo showing how the local water source at Choling has dried up due to the construction of the Karcham Wangtoo project, Photo taken on Nov 19 2010

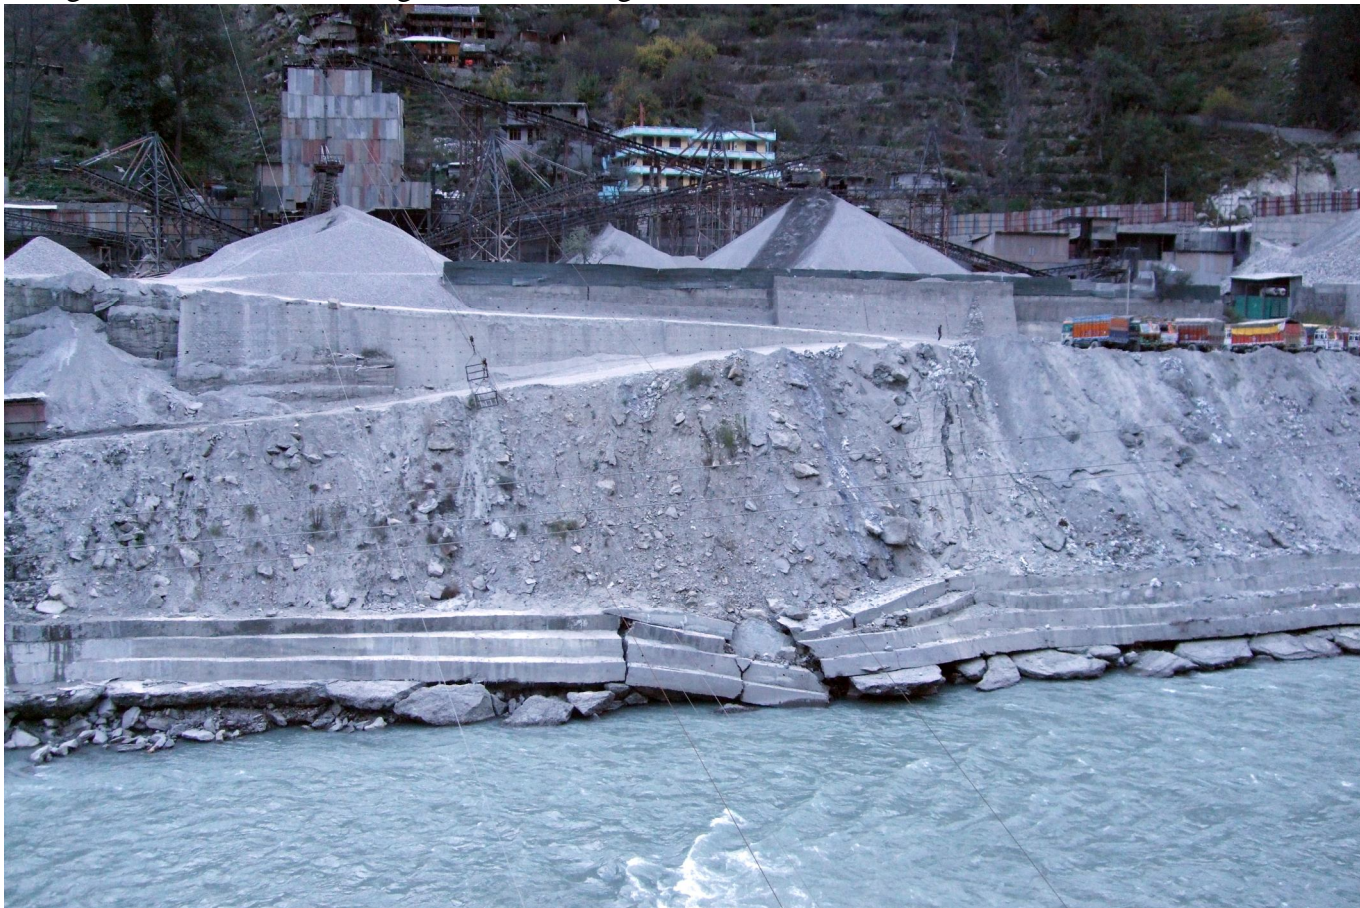
8. Photo showing the broken flood protection wall along the Sutlej River downstream of Karcham Wangtoo dam is broken leading to muck flowing into the river.. Photo taken on Nov 10 2010

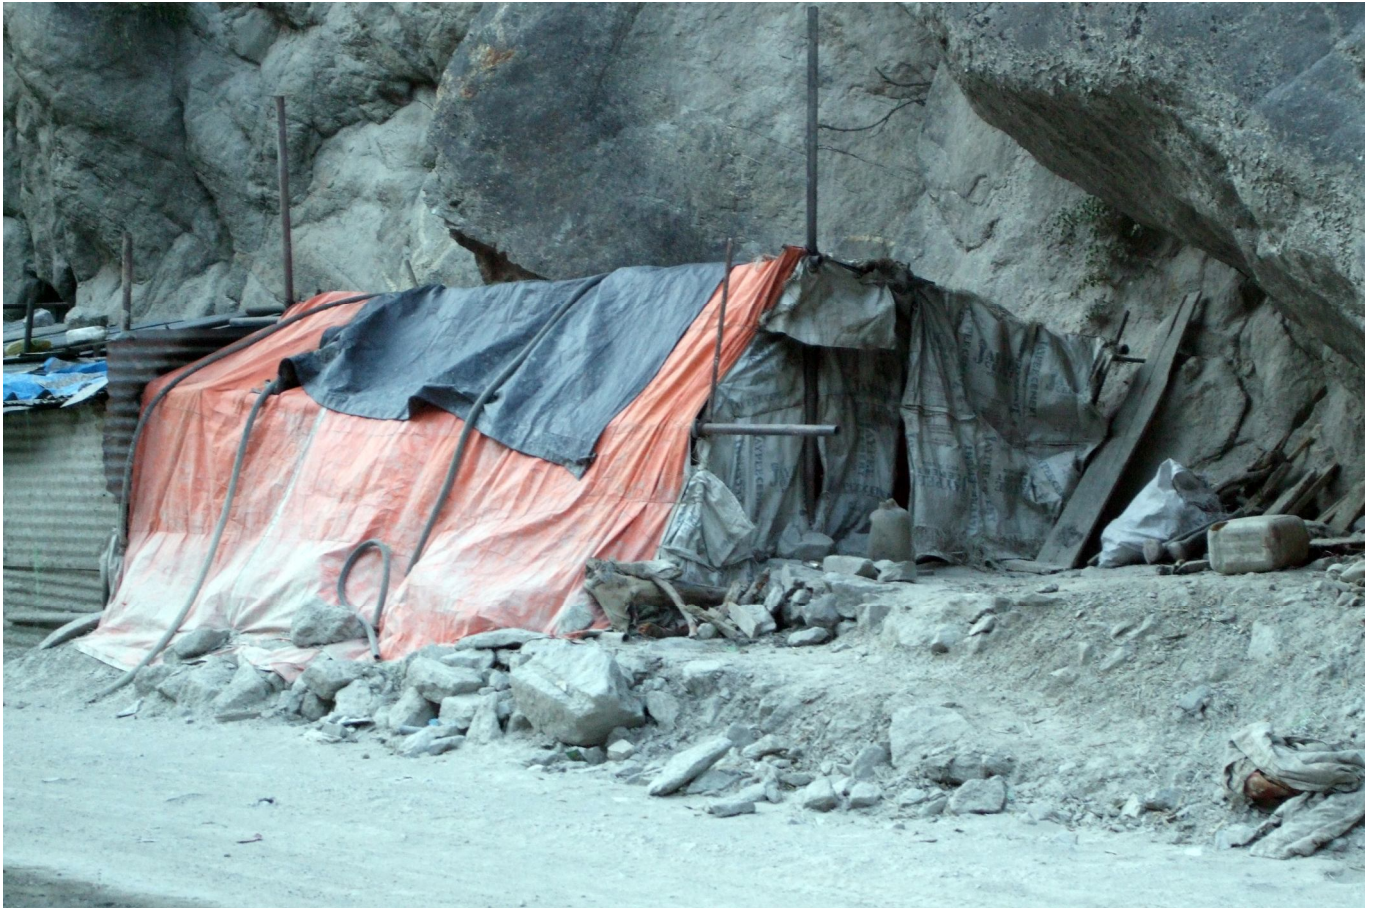
9. Photo showing poor housing for workers at the Karcham Wangtoo project site. Photo taken on Nov 10 2010

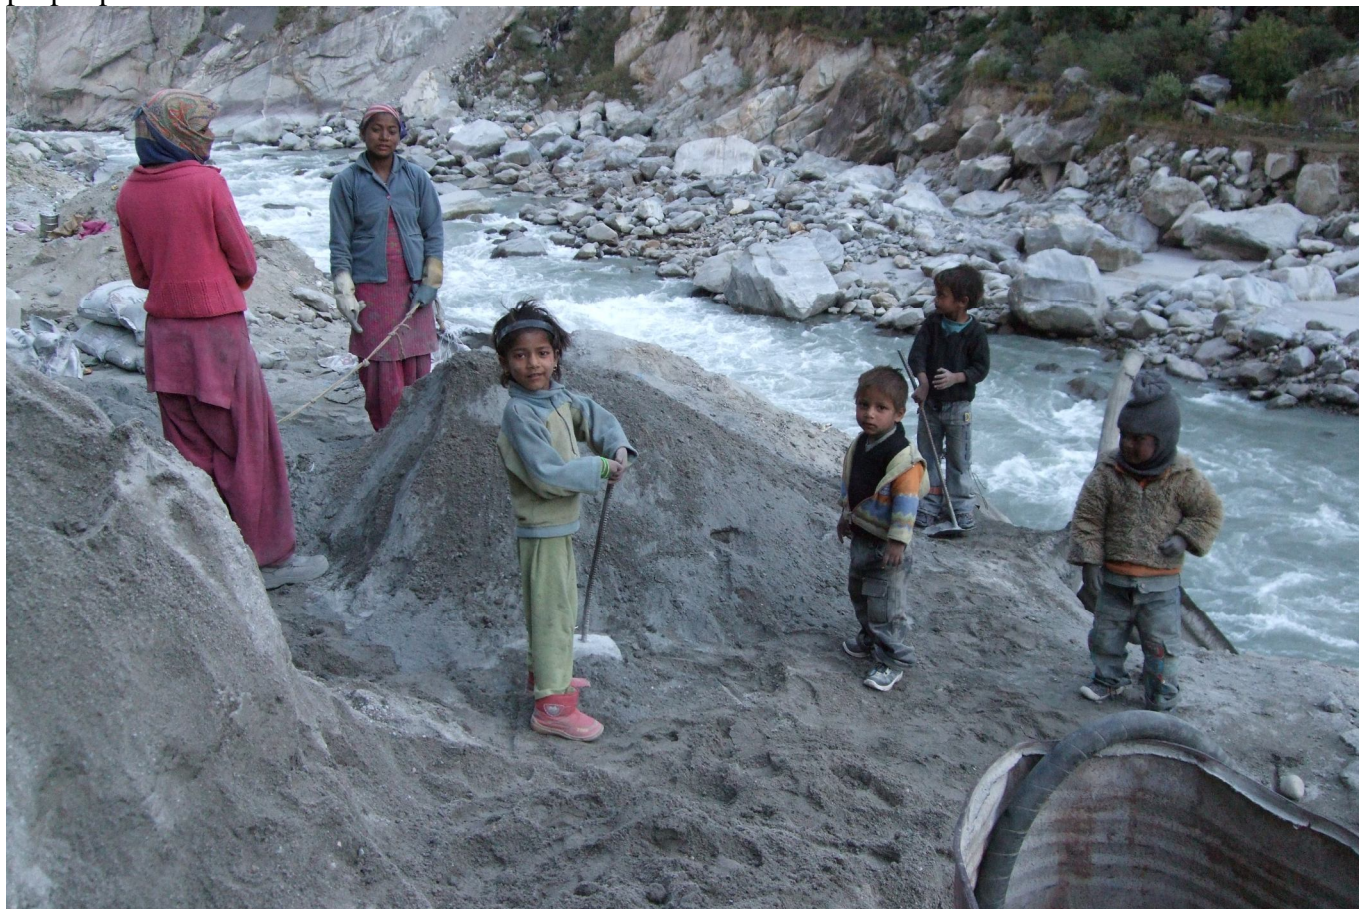
10. Photo showing how children are playing (or working? In which case it would be additional violation) close to the Sutlej river downstream from the Karcham Wangtoo Dam site. Photo taken on Nov 10 2010. Needless to add, the children of the workers are in dangerous situation here, being so close to the river known to be rapid, turbulent and changing flow patterns. The project developers should have ensured proper place for the children of the construction workers.

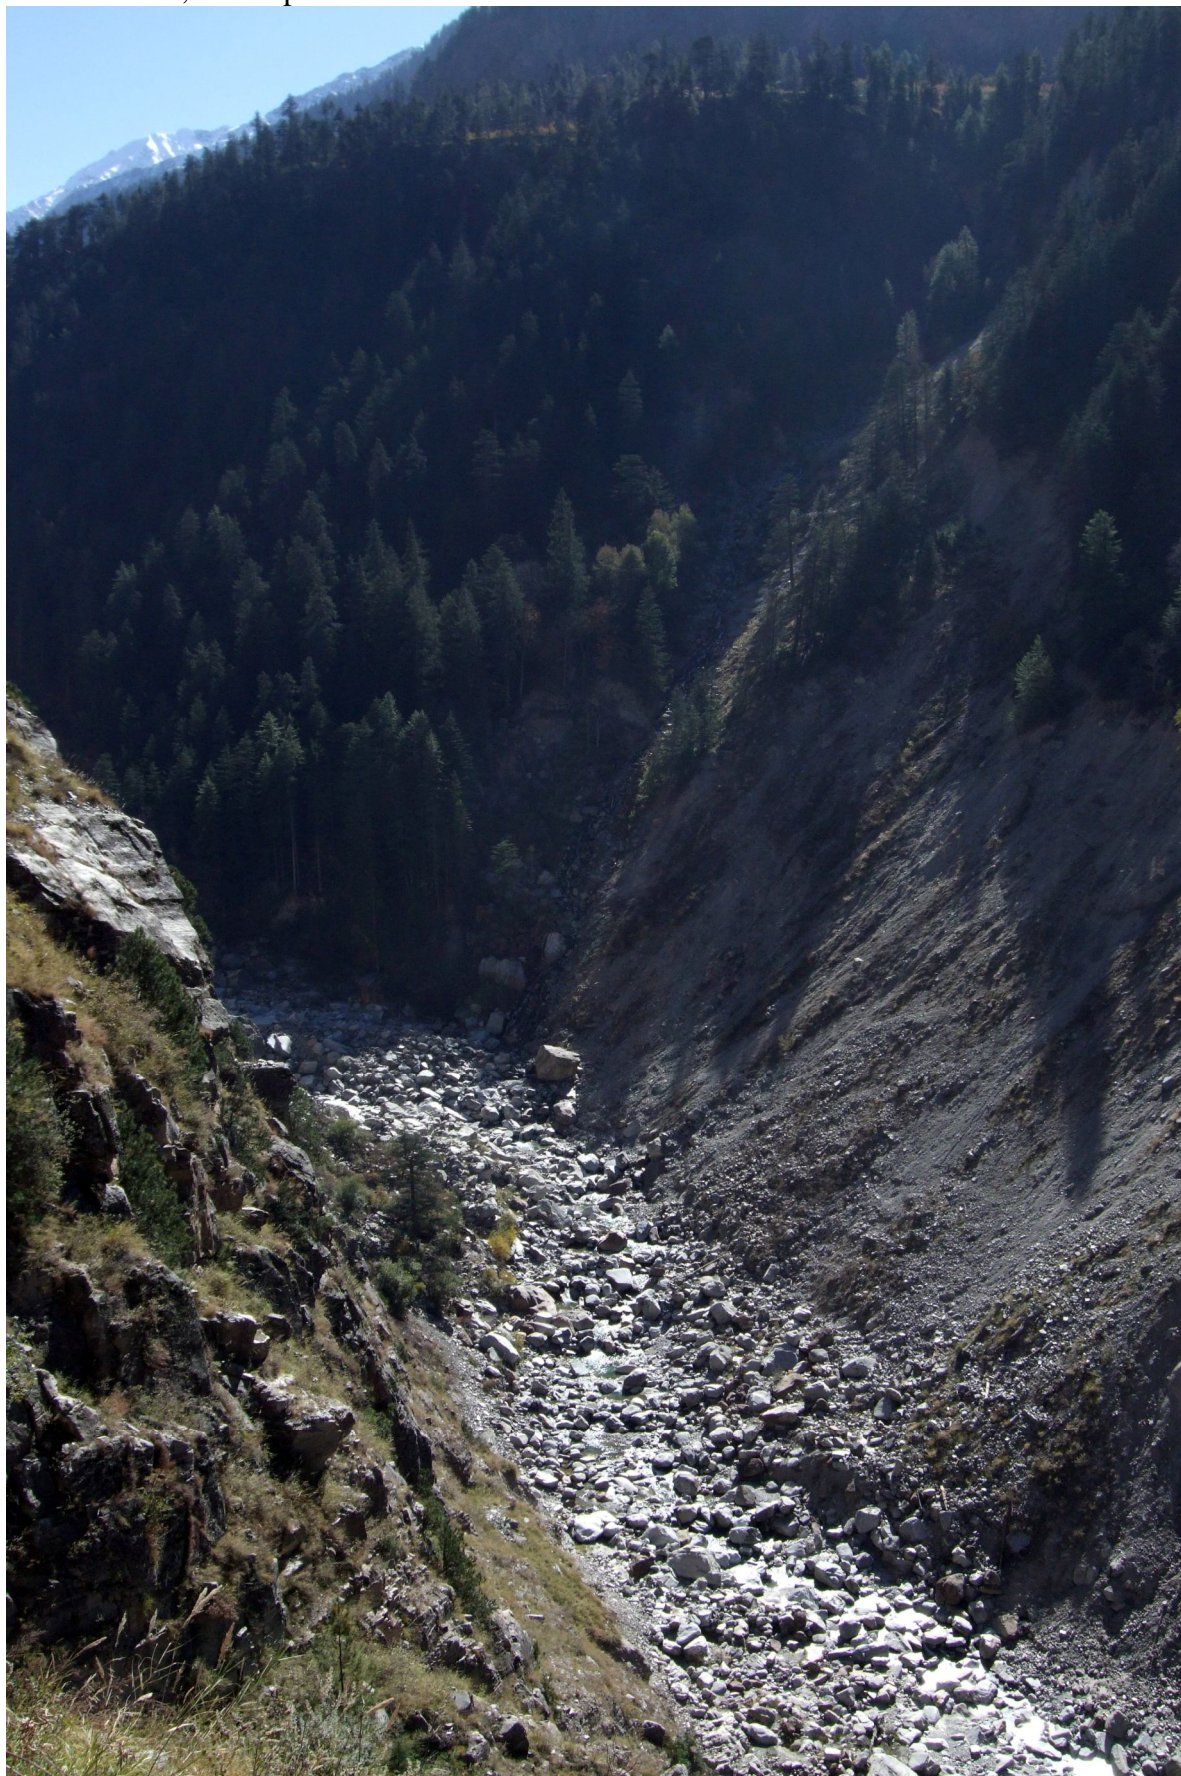
11. Photo showing how the river bed of Baspa river is completely dry 5 km downstream of the Baspa dam. Photo taken on Nov 12 2010. This means that the Baspa project is realising no water downstream from the dam, in complete violation of the Environment norms.

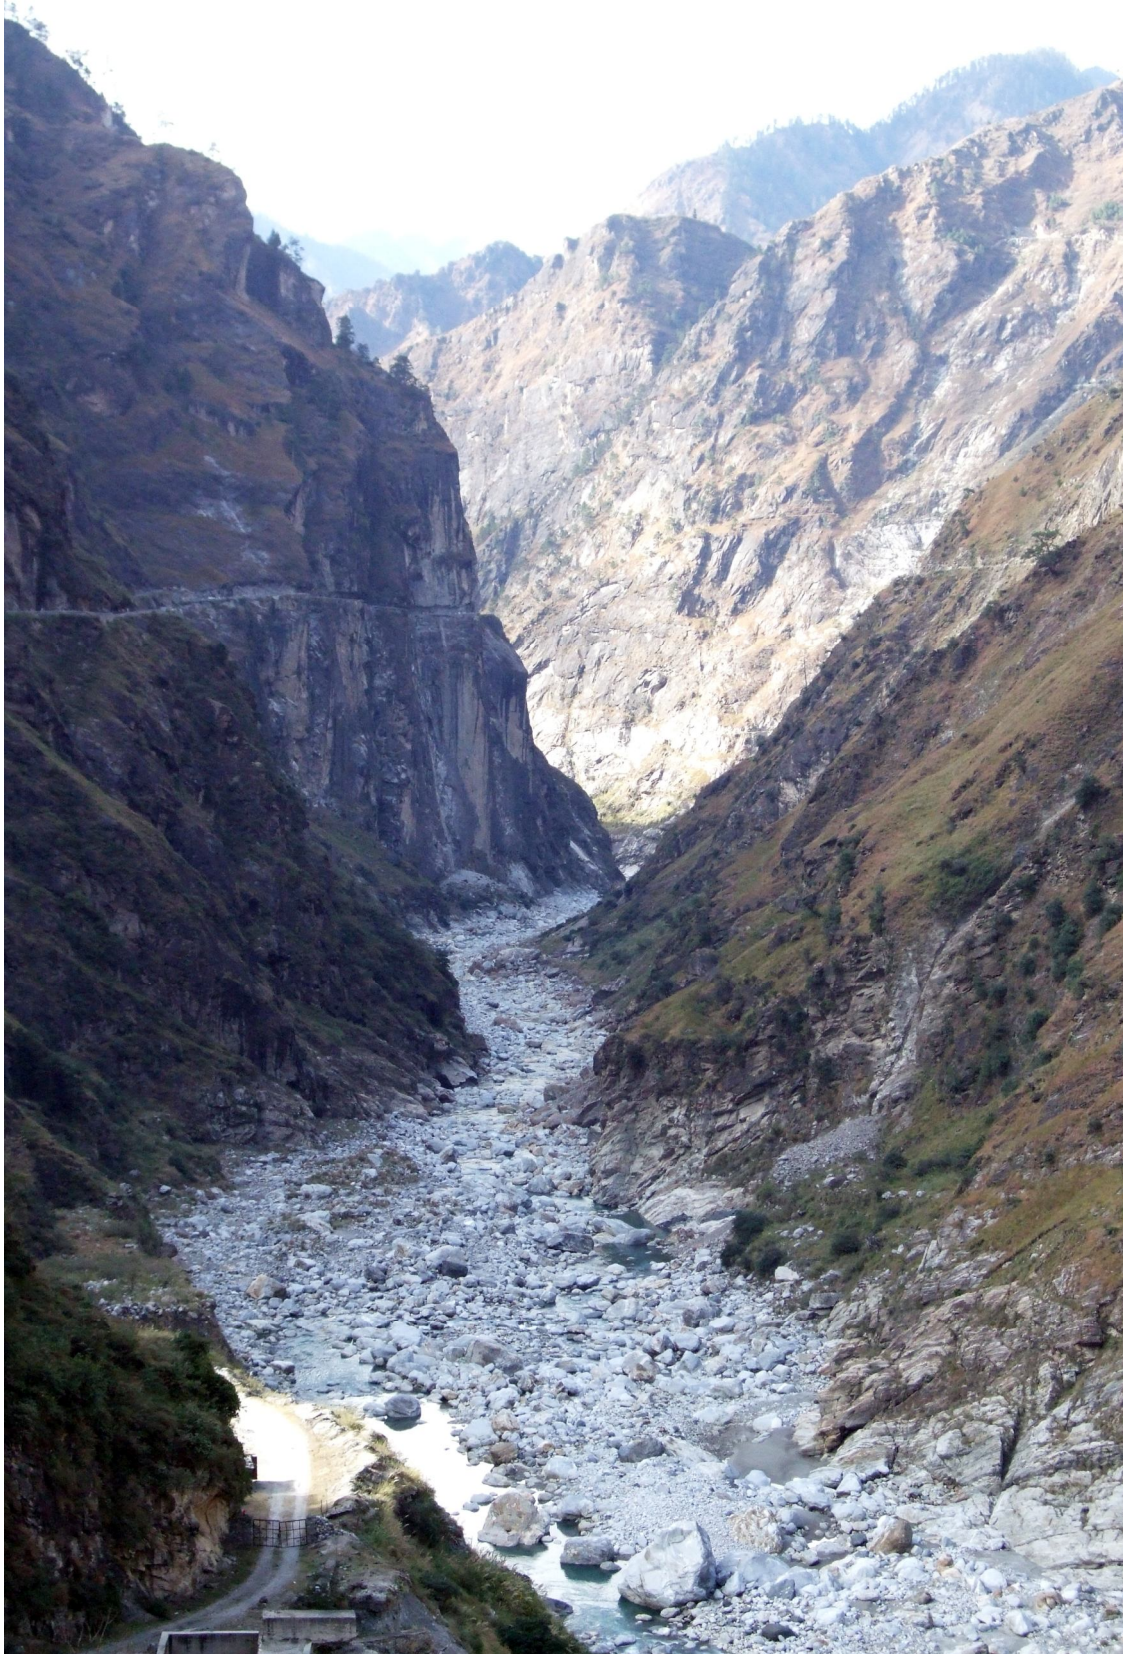
12. Photo showing how the Sutlej River is dry about 10 downstream from the dam site of Nathpa Jakhri Project. Photo taken on Nov 19 2010. This means that the Nathpa Jakhri dam is not releasing any water downstream from the dam in complete violation of Environmental norms.

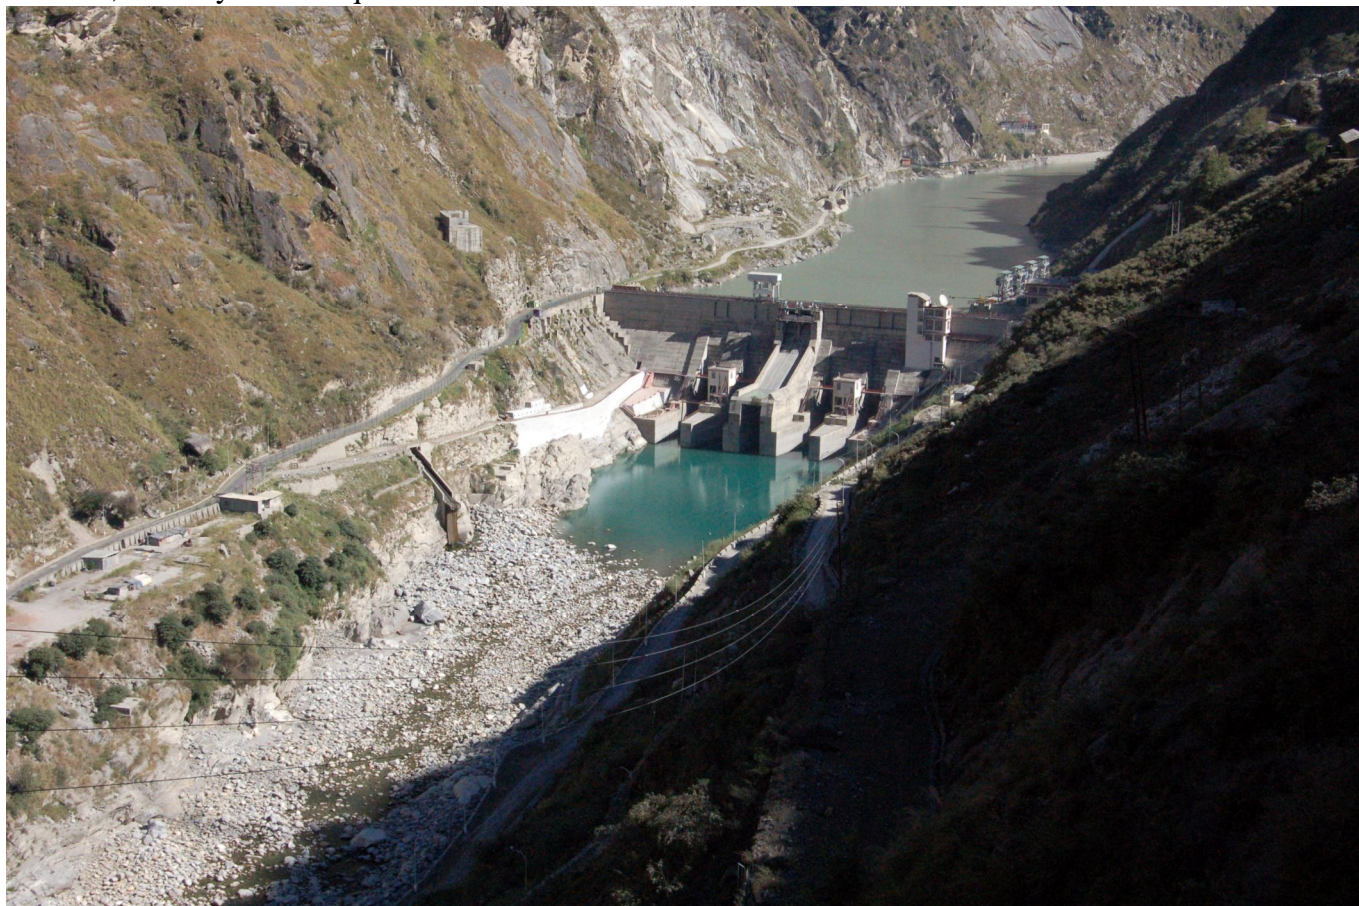
13 Photo showing the Nathpa Jakhri dam, it is clear that there is no minimum flow being released from the dam, contrary to the requirements of environment norms. Photo taken Nov 10 2010

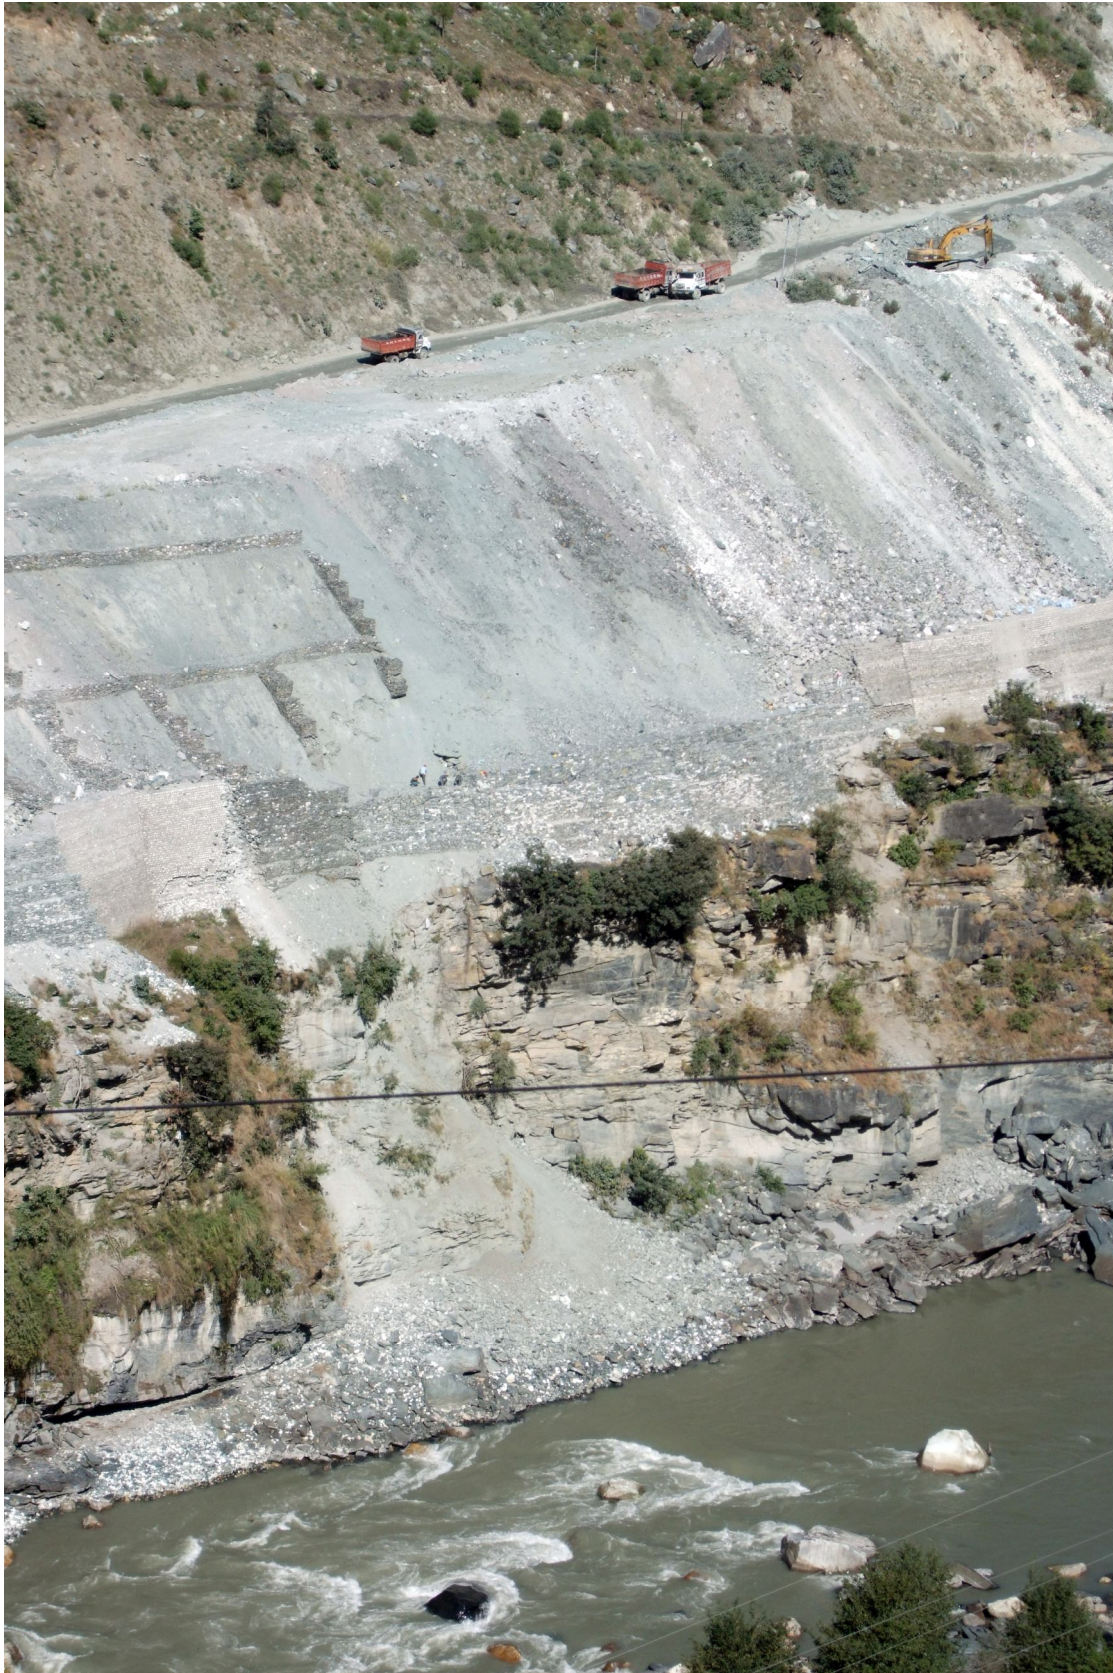
14. Photo showing how the muck is flowing into the Sutlej river. Photo taken a few km downstream from the dam site on Nov 9 2010. This dumping of muck into the river is completely illegal and against the environmental norms.
