HYDROPOWER PROJECTS OF HIMACHAL PRADESH VIOLATING ENVIRONMENTAL NORMS WITH IMPUNITY WILL THE MEF ACT WITH REQUIRED URGENCY?

Karcham Wangtoo HEP This 1000 MW installed capacity hydropower project is under implementation on Sutlej River in Kinnaur district in Himachal Pradesh. The environment clearance to the project was given by MEF on Nov 9, 2005. Below we are giving photos from this project site showing the violations that this project is indulging in muck disposal into the river.

Himanshu Thakkar (ht.sandrp@gmail.com)
South Asia Network on Dams, Rivers & People (www.sandrp.in)

January 31 2011

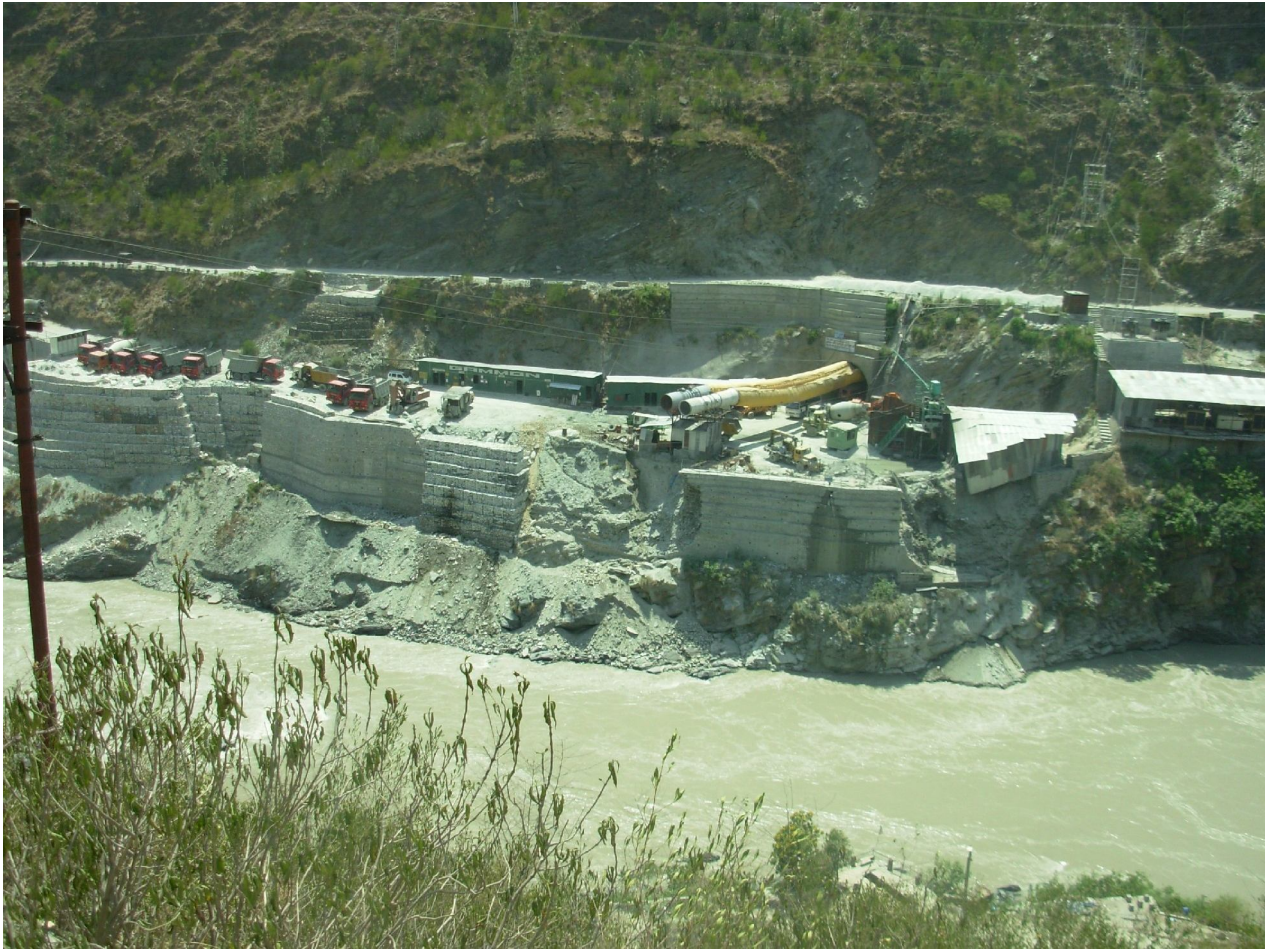
15. This is not the first time Rampur project has been indulging in this. Here is an earlier photo showing how the muck is flowing from the project into the Sutlej River. Photo taken at the adit near the Bahava panchayat in June 2009. When this was pointed out to the World Bank in early 2010, they responded that the damaged wall was reconstructed in three months!!
