Study of water supply & sanitation practices in India using geographic information systems: Some design & other considerations in a village setting

*Departments of Community Health & *Gastrointestinal Sciences, Christian Medical College, Vellore, India*

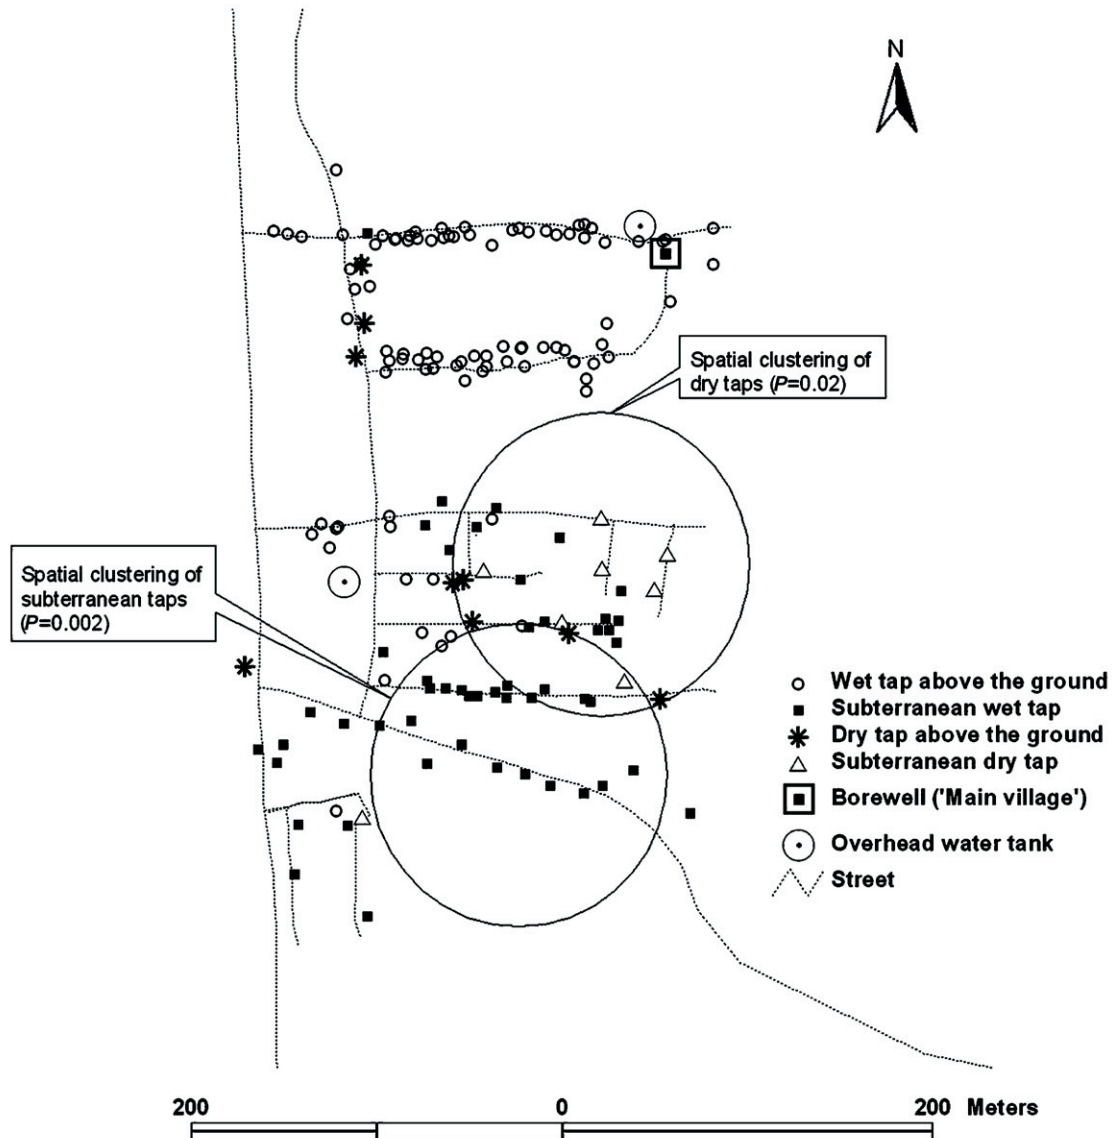
Taps were located at varying intervals along the street and there were many places where taps were missing. Interviews with the 'pump driver' established that the water supply was intermittent and varied from two hours in the 'Main village' to half an hour in the '*Harijan* colony'. Some taps in the village that had no water during the two weeks of the survey were referred to as 'dry taps'. '*Harijan* colony' had a significantly larger number of 'dry taps' (14, 82.4%) compared to the 'Main village' (3, 17.6%) (P=0.008), and also a significantly larger number of subterranean taps [57 (98.3%) vs. 1 (1.7%) P<0.001)] (Fig. 2).

Clustering of dry taps (most likely spatial cluster of dry taps, observed = 12, expected = 5.32) was in the eastern part of the '*Harijan* colony' (12.821178 N, 79.134605 E), with a radius of 0.08 km (log-likelihood ratio = 8.36, P=0.02). There was also significant

Fig. 2. Distribution of taps and tanks and borewell in Nelvoy village. Circles represent the spatial clustering of dry and subterranean taps. The borewell supplying the '*Harijan* colony' was located about 1.5 km to the west of the village.

spatial clustering of subterranean taps (observed = 24, expected = 17.32, log-likelihood ratio = 9.71, *P*=0.002) in the southern part of the 'colony' (12.820203 N, 79.134237 E), with a radius of 0.08 km.

The guidelines also specify the maximum permissible taps per tank (depending on its capacity) and prohibit people from lowering taps into pits (referred to as subterranean taps). At the distal end of '*Harijan* colony' a cluster of subterranean taps was seen inside dug pits, which was an indirect evidence of lower water pressure. This also resulted in sewage channels being at a higher level than the taps. After rain, entry of sewage through these taps was a distinct possibility.

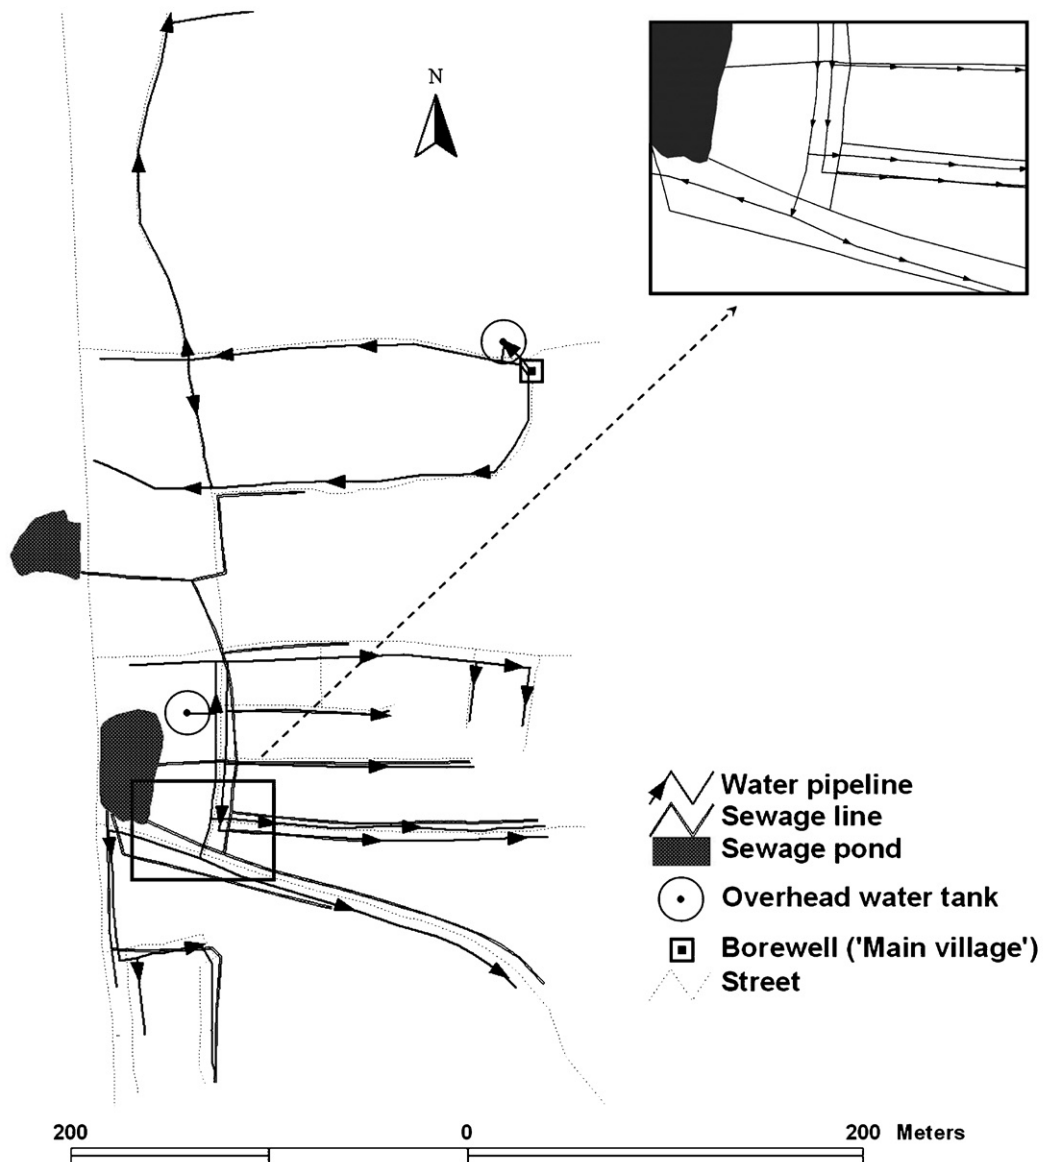
Sewage from the entire village drained into a common open pond on the opposite side of the highway. Another sewage collection (pond) draining the *Harijan* colony was located within 20 m of the central water storage tank (Fig. 3). Layering of the environmental attributes showed close proximity of

Fig. 3. Water pipelines and sewage channels in Nelvoy village. Inset shows the spatial proximity of water pipelines and sewage channels in '*Harijan* colony'.

water pipes to sewage, garbage and faecal matter. In most places, the water pipes were barely 5 m from the sewage channels and in some places they were less than 2 m away. There were places where sewage channels ran above the buried water pipes; while in other places, water supply pipes crossed the sewage channels (Fig. 3 inset).

In Tamil Nadu, there are guidelines for provision of potable drinking water in villages and to ensure segregation of sewage and drinking water. This includes setting up a village level water and sanitation committee to formulate a master plan for sewage and drainage [20]. These guidelines state that water pipes should not go through sewage or should not be submerged in sewage at any point. However in this village, as with other villages, sewage channels were found to run parallel to water pipes and cross them at various junctions. Since these are open sewage channels, there is the possibility of sewage mixing with the piped water, especially as the water supply is intermittent, causing negative pressure in pipes. In order to ensure proper segregation of sewage and faeces from drinking water, alternate designs are needed. Elevating the water pipe at places where water lines cross sewage and covering the sewage channels at junctions are possible methods to minimize contact of sewage with drinking water.

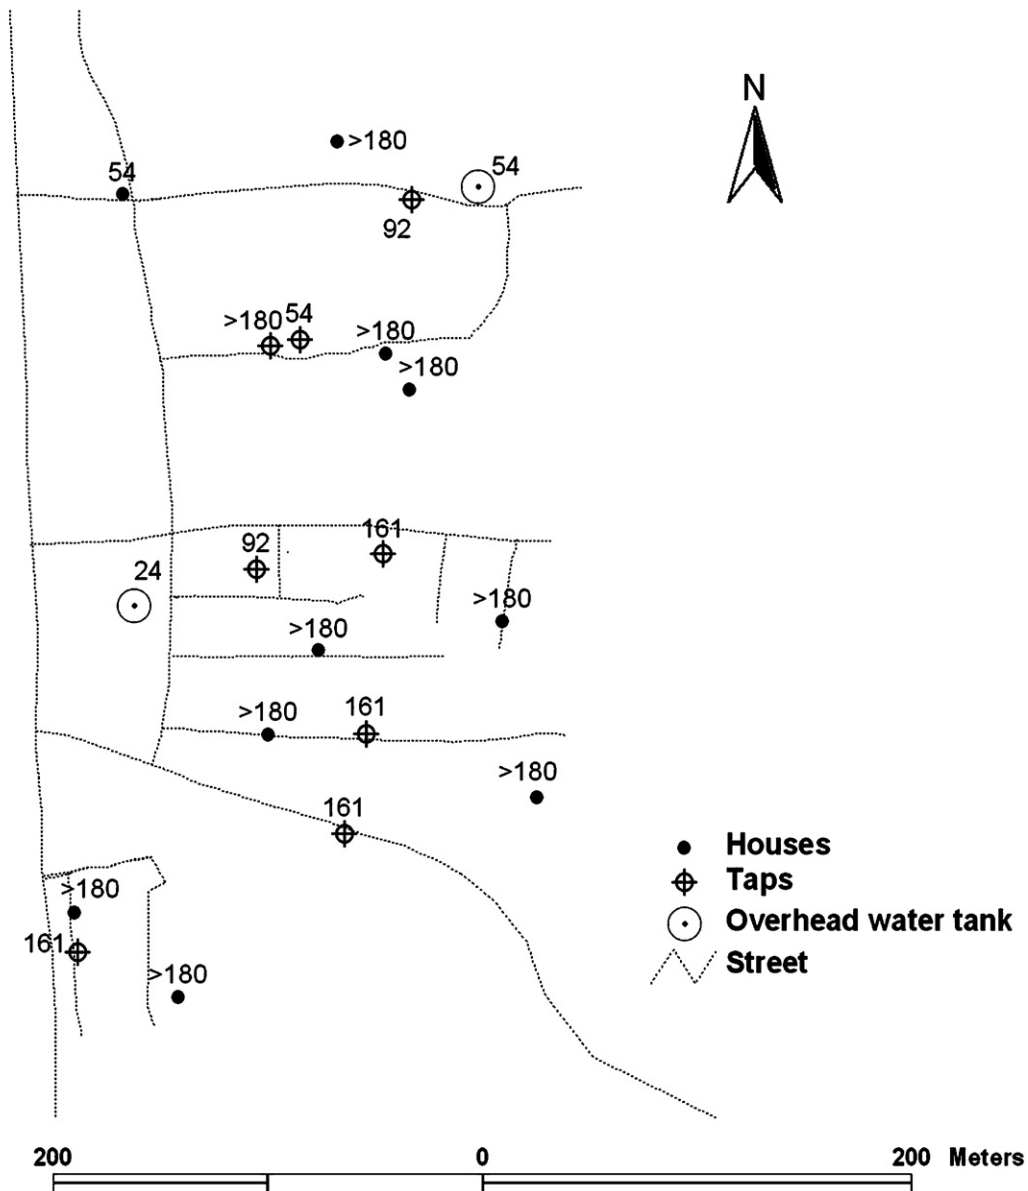
Confirmed coliform counts in water samples from the two tanks were 24 and 54/100 ml respectively, whereas the counts in the eight taps ranged from 54 to >180/100 ml; nine of ten household samples showed

coliform counts greater than 180/100 ml (Fig. 4). The difference in contamination levels between the household, tank and tap samples was statistically significant (Kruskal-Wallis test, P=0.004) (Table).

The water in the overhead tank of the 'Main village' was treated with bleaching powder once every fortnight, while in the '*Harijan* colony' it was added once a month. None of the 20 water samples tested had any residual chlorine. When asked about chlorination practices, residents complained that they did not like the smell of chlorine.

Fig. 4. Distribution of tanks, taps and houses from which water samples were obtained for presumptive coliform counts.
