CLOSING THE DEMAND-SUPPLY GAP THROUGH RAINWATER HARVESTING:

A Case Study of Sargasan, Gujarat, India

**International Symposium on Artificial Recharge (ISAR-4)
Adelaide, Australia**

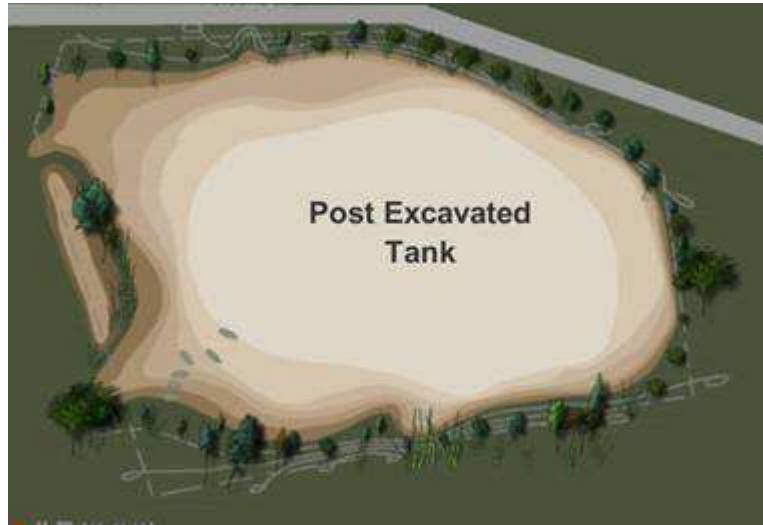
Fig. 7: Post Excavation Contours of the Tank

Based on the post excavation capacity-elevation characteristic of the tank, estimate of water percolated was made which is shown in the following figure:

Survey of the tank was carried out to help estimate storage capacities at various elevations. The tank is ellipsoidal with diagonals measuring 110m and 140 m, with a maximum depth from the bank of 6 m. Considering the location of the spill way, the effective depth of the tank is 5.2 m. The surface area of the tank is 1.35 ha with a storage capacity of 28 million litres. A gauge was installed in the tank to measure the tank water level. From the capacity-elevation curve, one could easily derive the volume of standing water in the tank. The community was trained to take the readings on the gauge and provide to VIKSAT.
